1131A-01A

# S E R V I C E                      N O T E

## 1131A Infiniimax Probe Amplifier 3.5GHz

**Possible fractured solder joint on input pin**

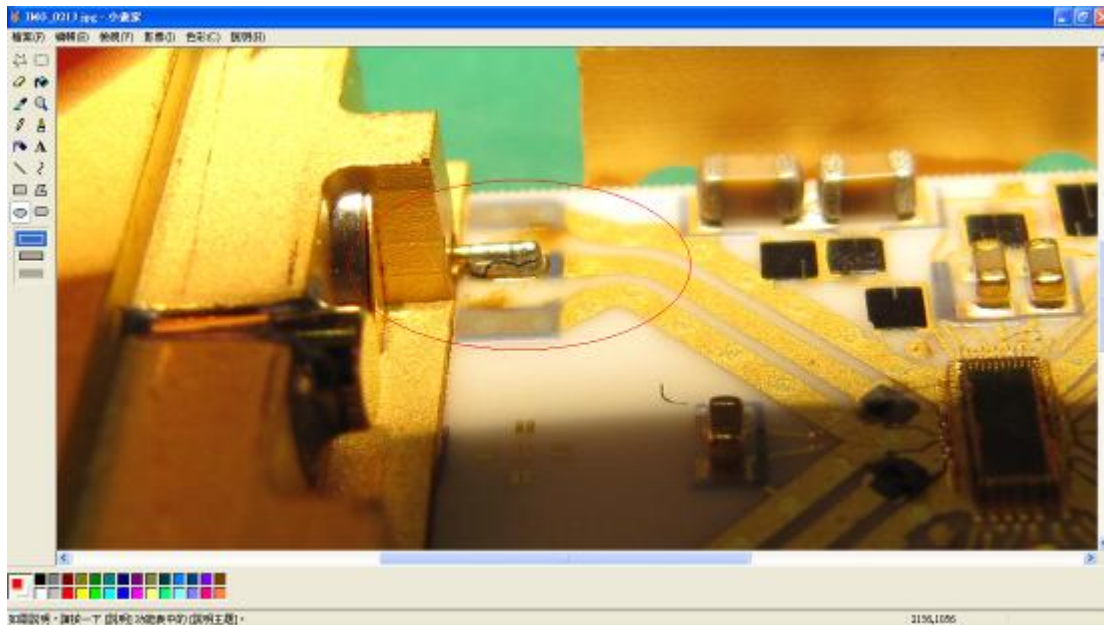
There is a possibility that the input pin solder joint may be fractured. You may also find the input pin bent, broken off, or stuck into the female connector of a probe head.

The above picture shows a fractured solder joint.

5. If you determine that the solder joint is fractured, bent, broken, or probe head parts stuck to a probe pin, replace with a new 01131-68701 probe amplifier. Charge the replacement cost to factory warranty.
