# **S E R V I C E                      N O T E**

## 1168A Infiniimax Probe Amplifier 10GHz

**Serial Numbers: US00000000 up to US49491010**

**Possible fractured solder joint on input pin**

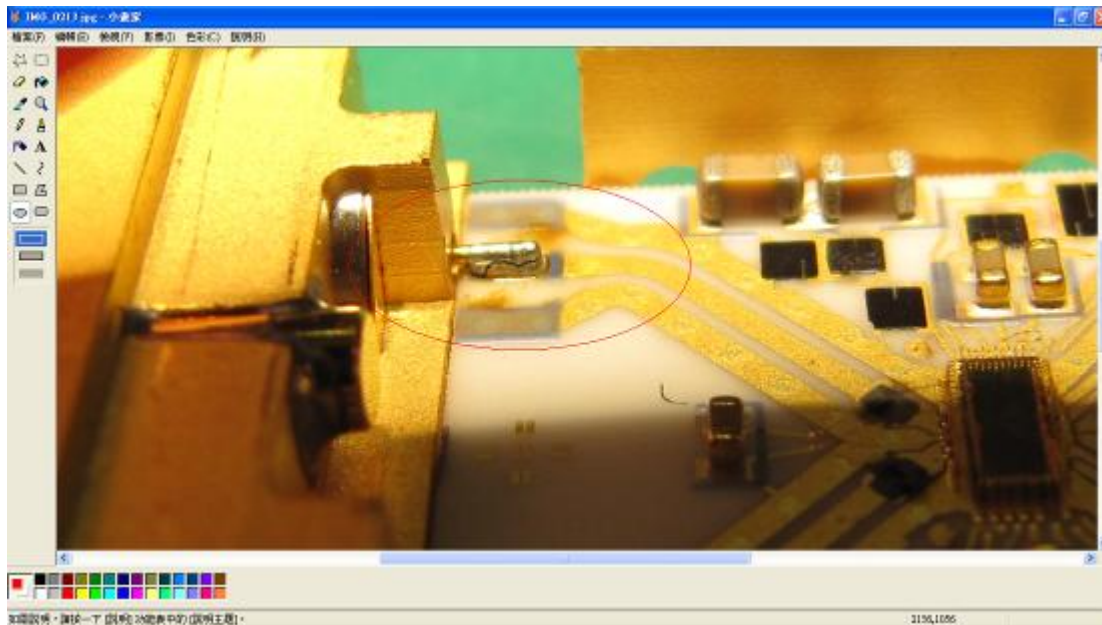
There is a possibility that the input pin solder joint may be fractured. You may also find the input pin bent, broken off, or stuck into the female connector of a probe head.

The above picture shows a fractured solder joint.

5. If you determine that the solder joint is fractured, bent, broken, or probe head parts stuck to a probe pin, replace with a new 01168-68701 probe amplifier. Charge the replacement cost to factory warranty.

If you find the above mechanical defects, replace with a new 01168-68701 probe amplifier.

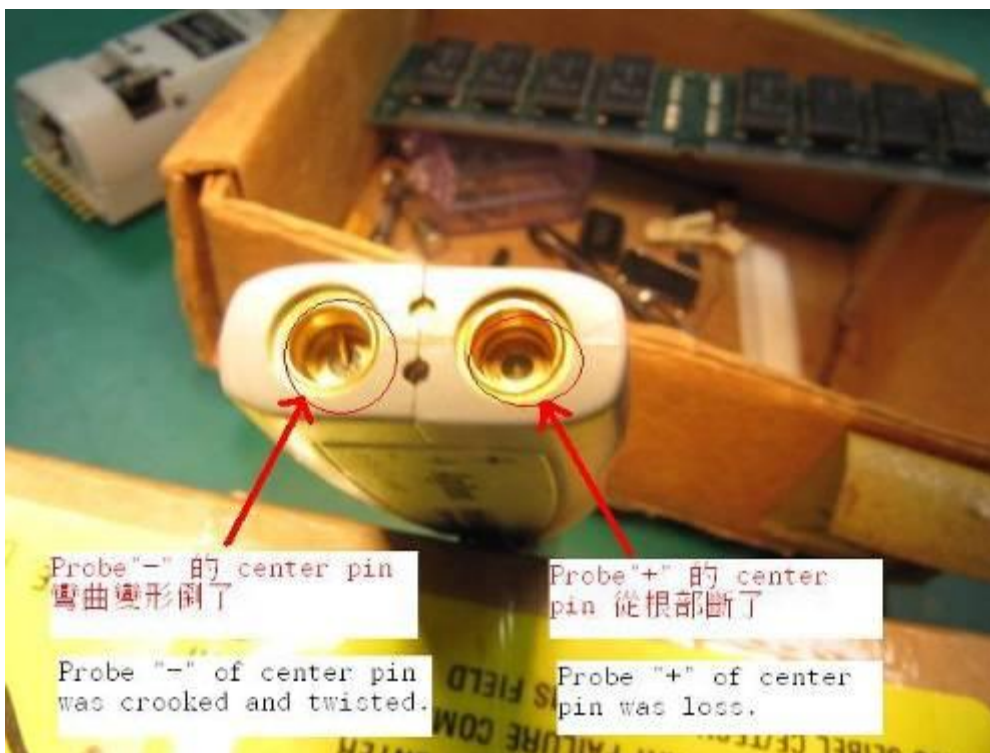
The above picture shows a bent male pin and a broken male pin. The longer male pin could cause the pin to bend or eventually break when connected to a probe head.
