1169A-01B

**S E R V I C E                      N O T E**Supersedes:  
1169A-01A

## 1169A Infiniimax Probe Amplifier 12GHz

**Possible fractured solder joint on input pin****Parts Required:**

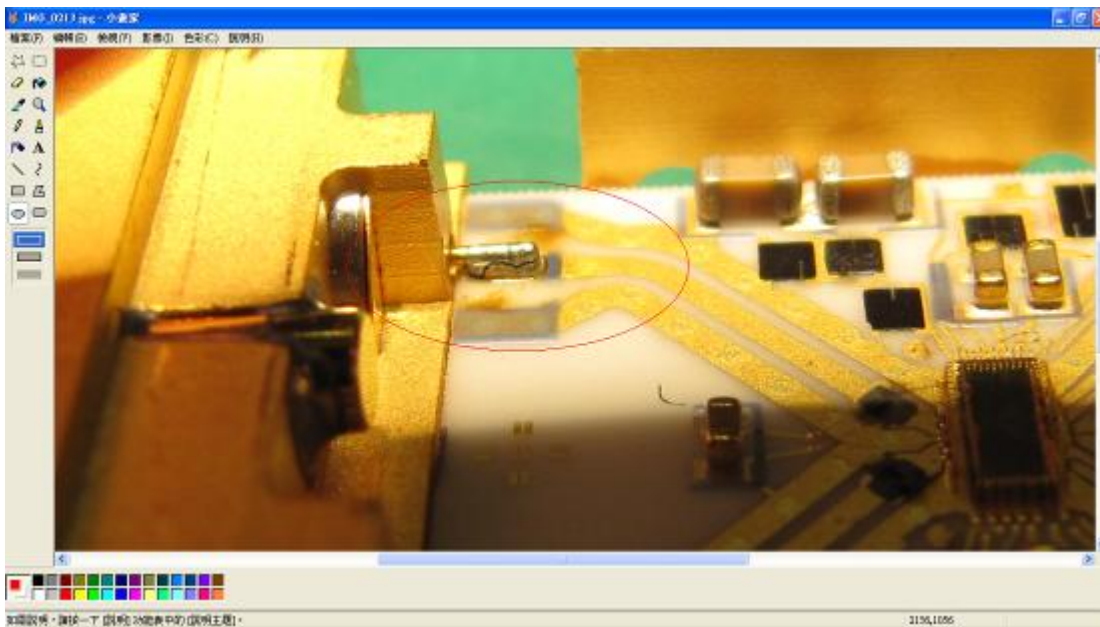
There is a possibility that the input pin solder joint may be fractured. You may also find the input pin bent, broken off, or stuck into the female connector of a probe head.

The above picture shows a fractured solder joint.

5. If you determine that the solder joint is fractured, bent, broken, or probe head parts stuck to a probe pin, replace with a new 01169-68701 probe amplifier. Charge the replacement cost to factory warranty.

If you find the above mechanical defects, replace with a new 01169-68701 probe amplifier.

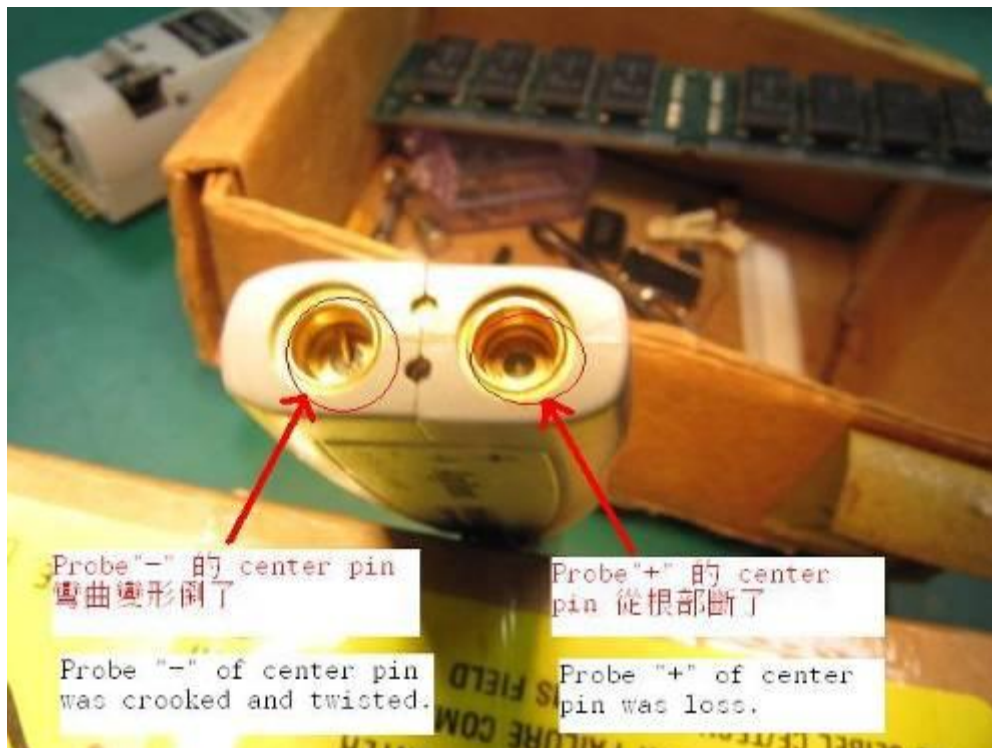
The above picture shows a bent male pin and a broken male pin. The longer male pin could cause the pin to bend or eventually break when connected to a probe head.
