MODIFICATION RECOMMENDED –
CORRECTS MANUFACTURING OR DESIGN DEFECTS

SN-1730B -01

S E R V I C E N O T E

1730B 1/2G Fibre Channel SAN Tester

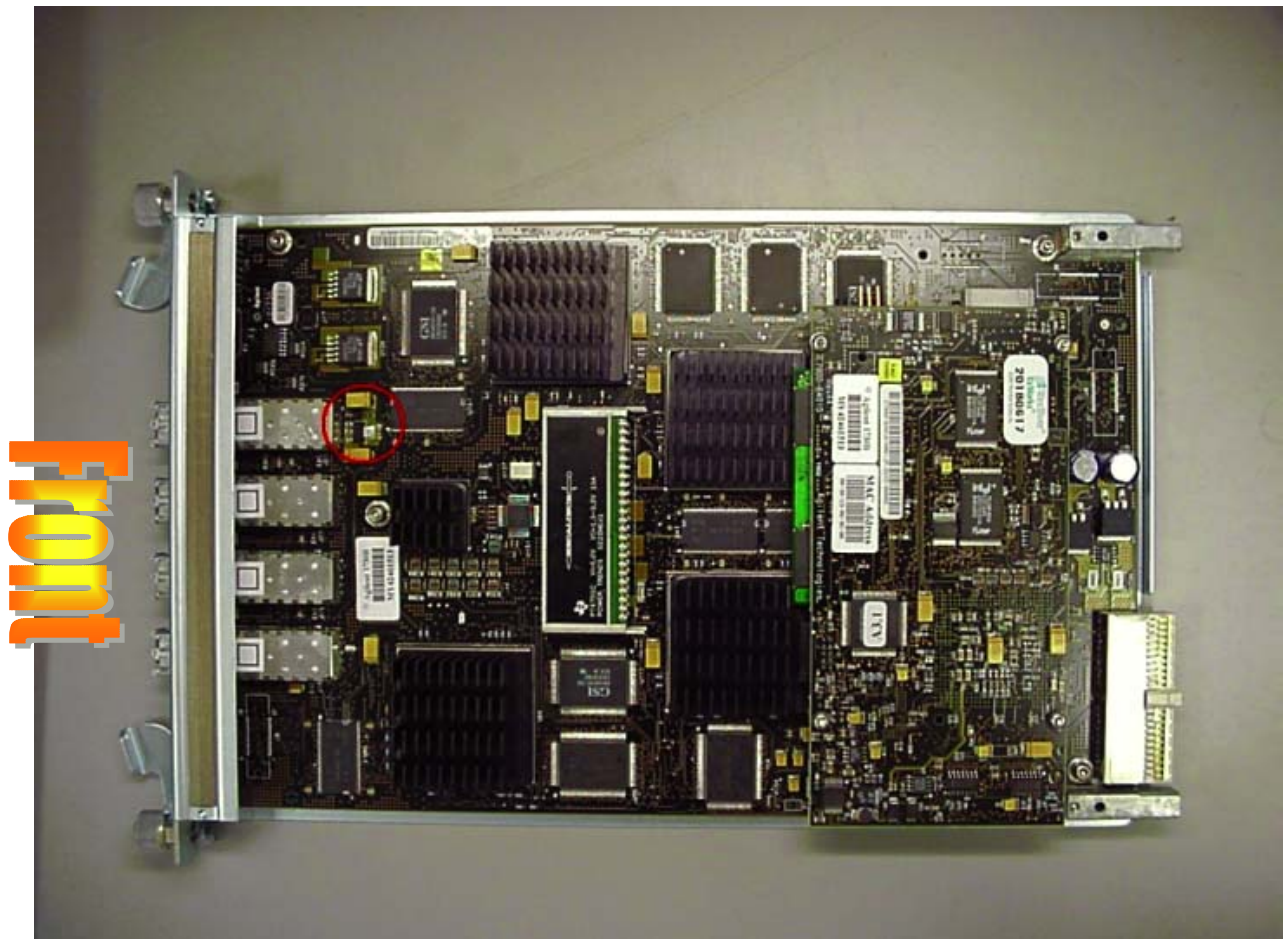
Diagram 1:

- **Surface mount resistor designated R484 is the wrong value and can lead to system hangs, crashes or report of disparity errors.**
- **Surface mount capacitor designated C592 MAY have the wrong value and can lead to system hangs and crashes**

1730B 1/2G FC SAN Tester. Note general location of resistor and capacitor.

Resistor R484 (see picture below) needs to be changed **from** PN-0699-3926 (121 ohms) **to** PN 0699-3911 (26.1ohms).

Visually inspect Capacitor C592 (see picture below). If value on capacitor is 476, then the capacitor needs to be changed **to** PN 0180-4976. Capacitor polarity must be respected. If the value on capacitor is 477, the capacitor does NOT need to be changed.

The “front” of the 1730B module is defined as the side with optical connectors. See Diagram 1

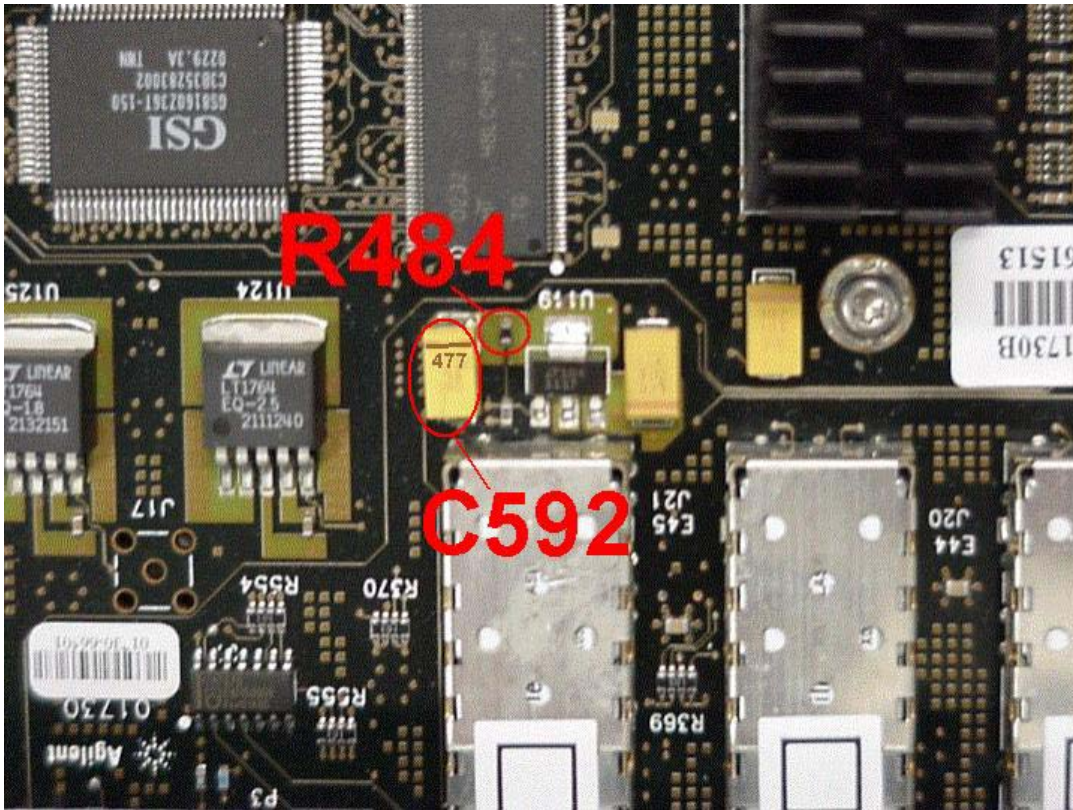
Diagram 2:

Exploded view of resistor and capacitor location. Reference red circle in diagram 1.

- 1) Remove resistor and replace it with 0699-3911. (see Diagram 2) One side of this resistor is connected to a power plane, so soldering the replacement resistor can be problematic. Inspect solder connections thoroughly to ensure a solid connection. You may want to re-flow the solder after the resistor is initially soldered down. You may have to use a higher -than -typical wattage solder tip to re-flow the solder.

- 2) Test for a good solder joint measuring the resistance between the replaced resistors front lead (that is the lead facing the front of the board) and the positive side of the capacitor directly next to the resistor. (Same capacitor referenced above). It should read about 26 ohms.

- 3) If capacitor needs to be changed, replace it with 0180-4976. The brown bar on the capacitor is oriented towards the “back” side of the board (see picture)
Inspect solder connections thoroughly to ensure a solid connection. You may want to re-flow the solder after the capacitor is initially soldered down.

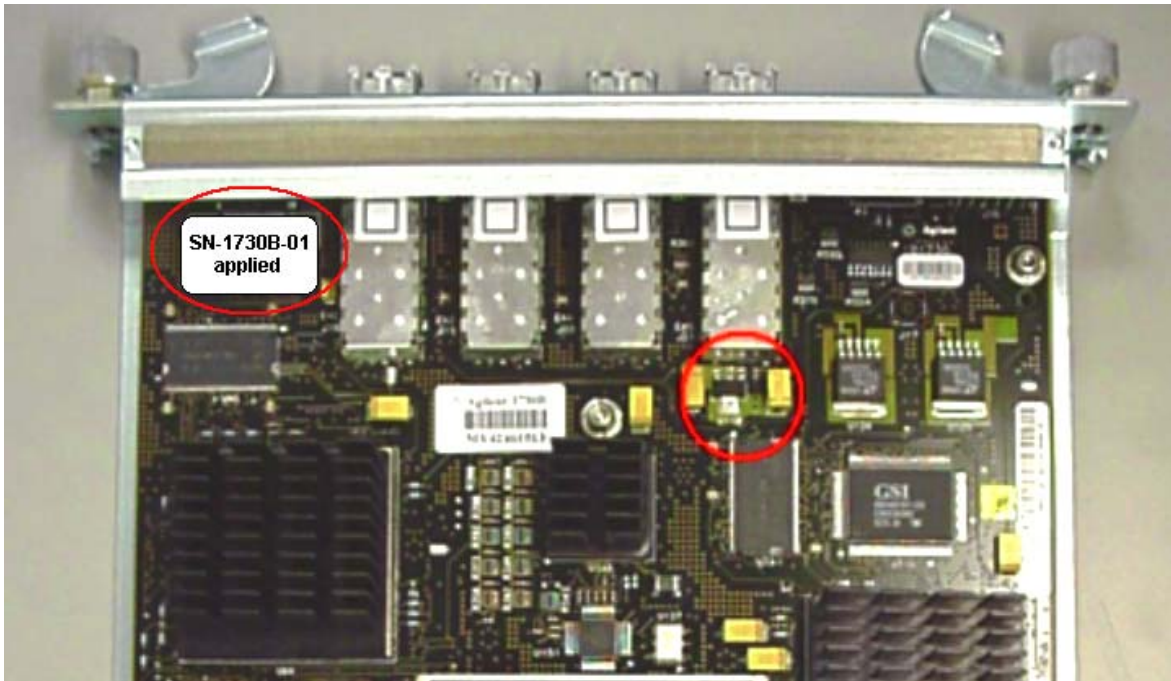
Sticker location

- 4) Attach Service Note Sticker . See Diagram 3
