3070-100

Modification Recommended Service Note

Keysight i3070 Series 5 and Series 6 In-Circuit Test System

The Problem – Standard VGA cable may cause Diagnostic Application Double Images.

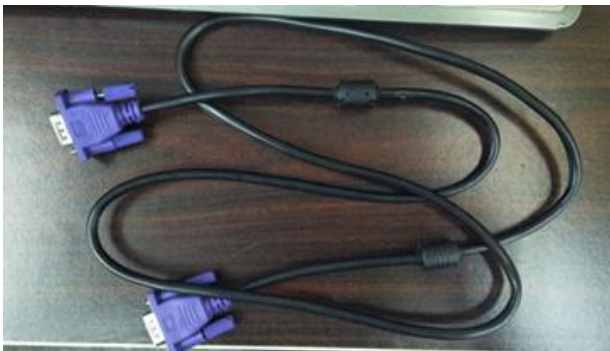
Figure 1: Existing VGA Cable (0960-3615)

The VGA cable (Keysight Part Number: 0960-3615) shown in Figure 1 below may cause Display Smearing/Shadow/Double image/Rolling Effect issues (Figure 2) on the In-Circuit System with Serial Number listed in this Service Note. This is due to the quality of the VGA cable batch bundled by Hewlett Package.

If you encountered the situation described, please replace the existing VGA cable with the high-resolution VGA cable in Figure 3a (Keysight Part Number: 8121-3377).

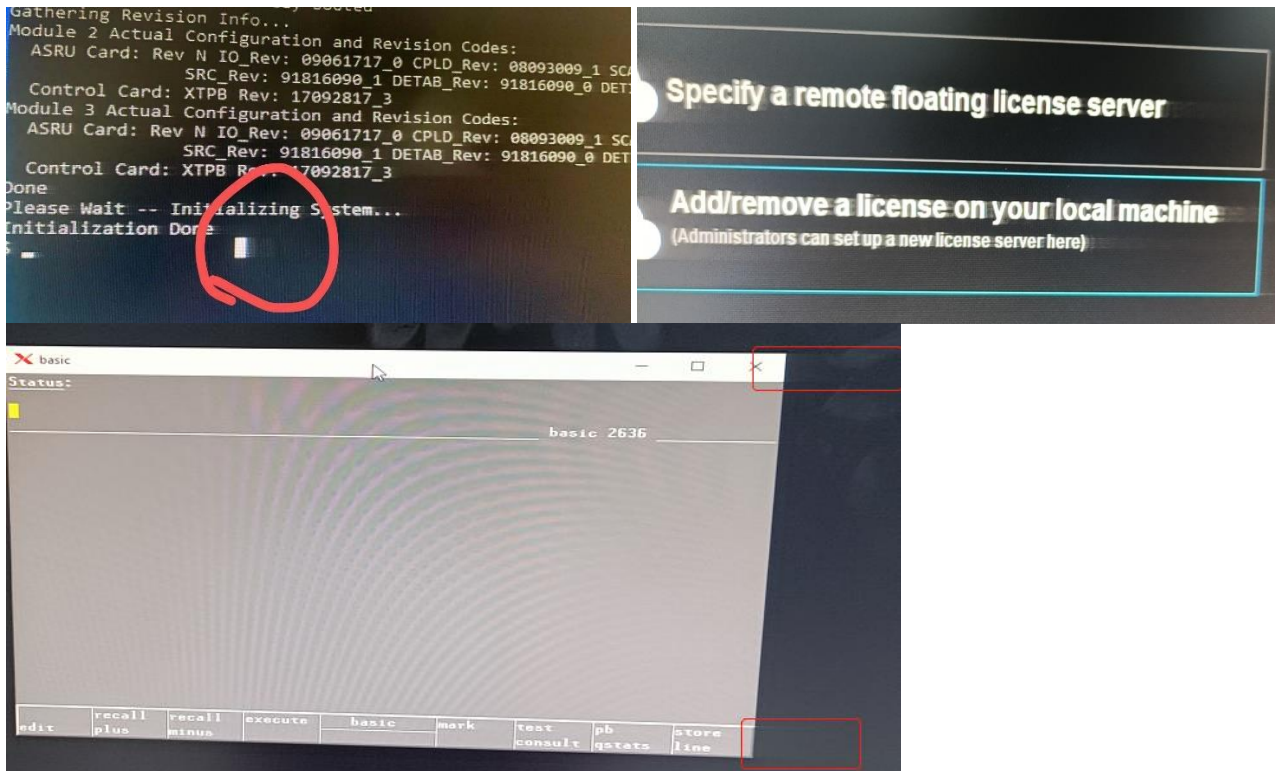
Figure 2: Double image or Rolling Effect issues

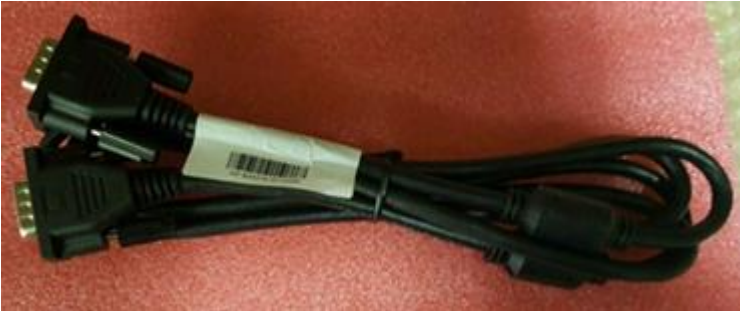
Figure 3a: new VGA cable KPN: 8121-3377

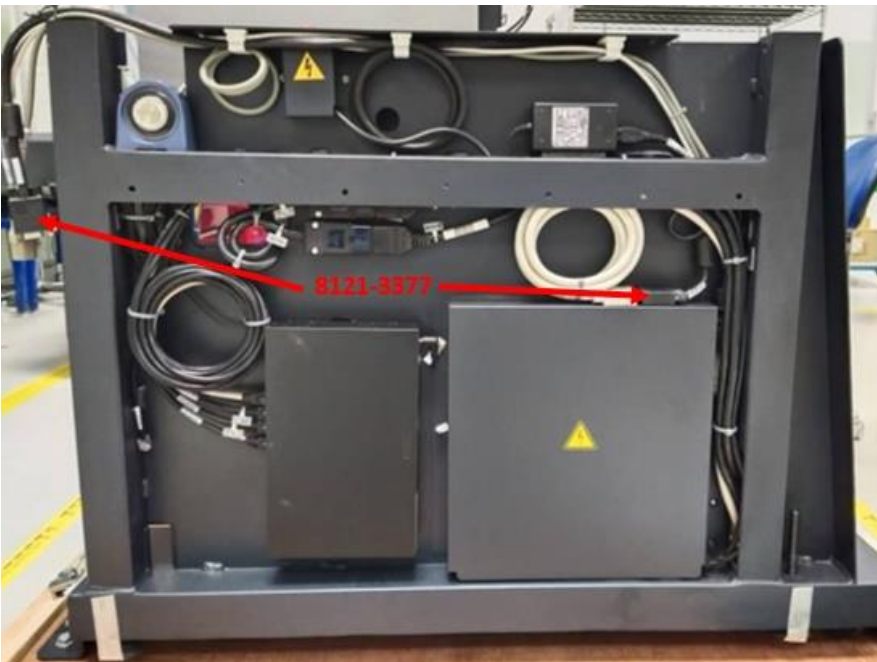
Figure 3b: Location of the VGA cable to replace

The Figure 3b shown the location of the VGA cable to replace.
