3070-74-S

S E R V I C E N O T E

Agilent 3070 Series 3 Board Test Systems

POSSIBLE ELECTRICAL SHOCK HAZARD

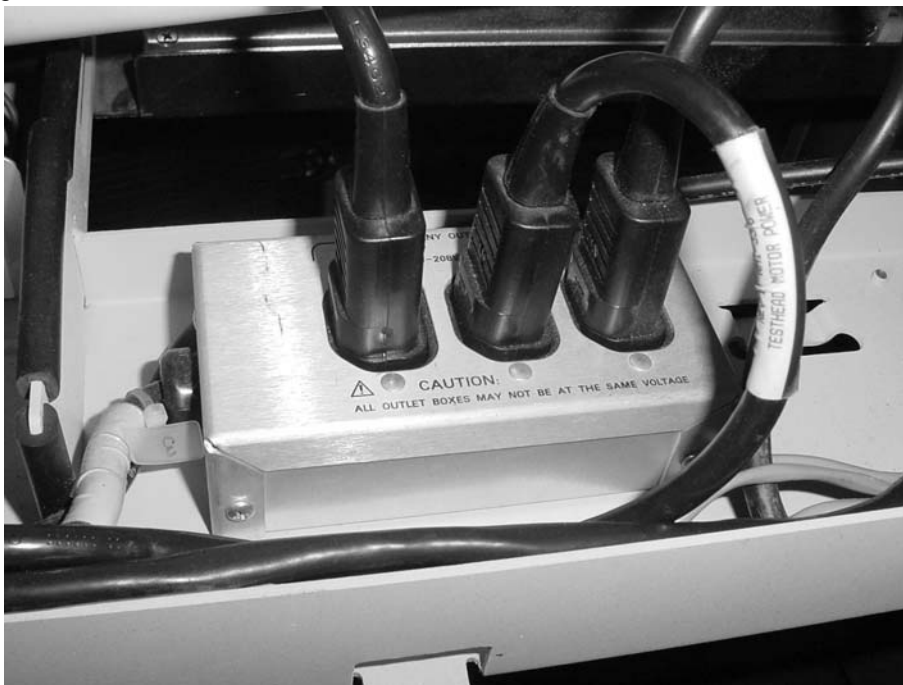
Agilent has identified a potential electrical safety hazard for a limited number of Agilent 3070 test systems related to the power outlet boxes used in the systems. In some 3070 Power outlet boxes, part numbers 03066-61641 and E4000-81603, the line, neutral, and ground wires are only connected by solder, without any type of mechanical connection causing a potential electrical safety hazard. Only outlet boxes with Agilent part numbers 03066-61641 and E4000-81603 manufactured by Carmel from Dec, 2002 to Aug 2004 have this problem. All outlet boxes manufactured by Logan with Agilent part numbers 03066-61635, 03066-61641, E4000-81601, E4000-81603, E4000-81623, and E4000-81610 are assembled to Agilent's specifications and are not affected by this safety alert. The outlet boxes with four sockets, Agilent Part Number E4000-61623, used in the support bay on some Series II and all Series 3 systems were all manufactured by Logan and are not affected by this safety alert.

The picture below shows one outlet box with three power cords installed. There is one outlet box for each module in a 3070. One power connector is for the 3070 module power unit. A second power connector is for the module blower. The third power connector is for the test head rotating motor, one per system.

- The solution involves replacing suspect power outlet boxes with new assemblies. The outlet box assembly consists of an outlet box with 3 receptacles, a 3 conductor power cord and an IEC320 Plug (Hubbell H320P). A service note compliance sticker will be attached to the system upon completion of the replacement and testing of the outlet box. The outlet box is attached to the 3070 frame via two Torx T20 type screws (0515-1922). The two Torx screws (0515-1922) will be reused on the new outlet box assembly. The Hubbell connector mates with a plug (see picture below) connected to the PDU E1135C.
