3070-91

S E R V I C E N O T E

Keysight i3070 Series 5 In-Circuit Test System

Control XTPA card new firmware 14091012_2.xsvf

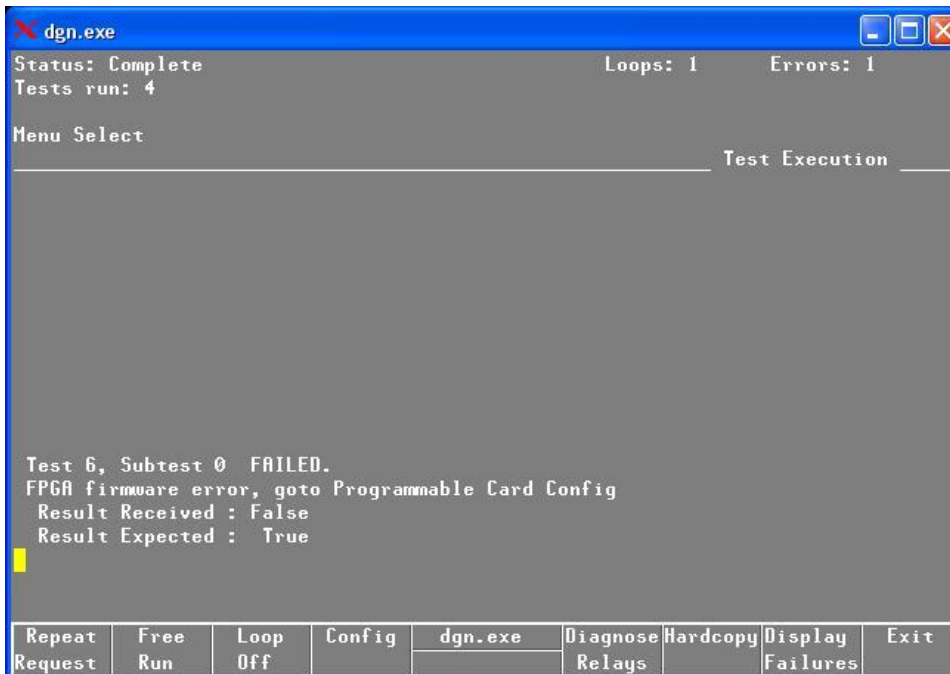
Figure 1: Diagnostics error message

The existing Control XTPA “11100709_2” firmware may encounter Diagnostics test 1256 safeguard timeout failure, although it doesn’t affect the control card functionality.

Users who have testheads that are installed with Control XTPA of one version and firmware release of another version may detected this differences at failing diagnostics “Test 6, Subtest 0” with the error “FPGA firmware error” (Figure 1). This is a symptom that the firmware versions are different.

The new Control XTPA “14091012_2” firmware is to improve safeguard timeout accuracy of diagnostics test 1256. It is recommended to update this new firmware to all the Control XTPA cards. There is no impact to Control XTP card. Hence, no action is required for XTP card.

- A. Check the firmware version on Control XTPA card
 - 1) Execute the testhead diagnostics application by double clicking on the “DGN” icon on the desktop (alternatively, type “dgn” at the command prompt in a shell window)
 - 2) To boot up the testhead,
 - i. Click on “Testhead Functns” (F4) and click on “Testhead Power On” (F1)
 - ii. After the testhead is booted up, click “Exit” till Service Package - Level 1.
 - iii. Then, select “Configuration”, follow by “Programmable Card Configuration”.
 - iv. Check on Actual and Expected value and execute the recommended action listed below.
