3070-97

Modification Available Performance Enhancement Service Note

Keysight i3070 Series 5 Inline In-Circuit Test System

The Problem – ESD Belt Guide Bar replacement for i3070 4 module Inline ICT

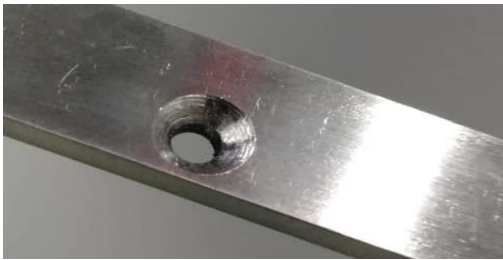
The existing conveyor belt guide bars can support anti-static and electrostatic discharge (ESD) belts. All ESD belts are within the material specification, but some of the ESD belts thickness are within the high side of the material tolerance specification causing the gap in between belt guide bar and conveyor rail become smaller.

Figure 1A: existing round shape screw hole

If you have used/changed to the ESD belts, the recommendation is to replace with the latest designed belt guide bar. It has new oval shape screw hole (Figure 1B) to accommodate ESD belts thickness that are within the high side of the material tolerance specification.

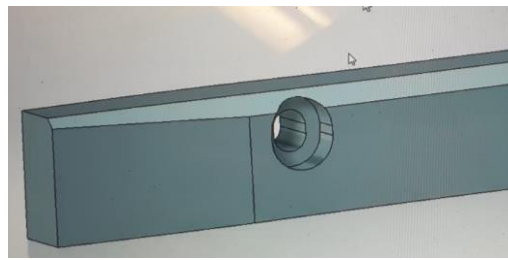
Figure 1B: new oval shape screw hole

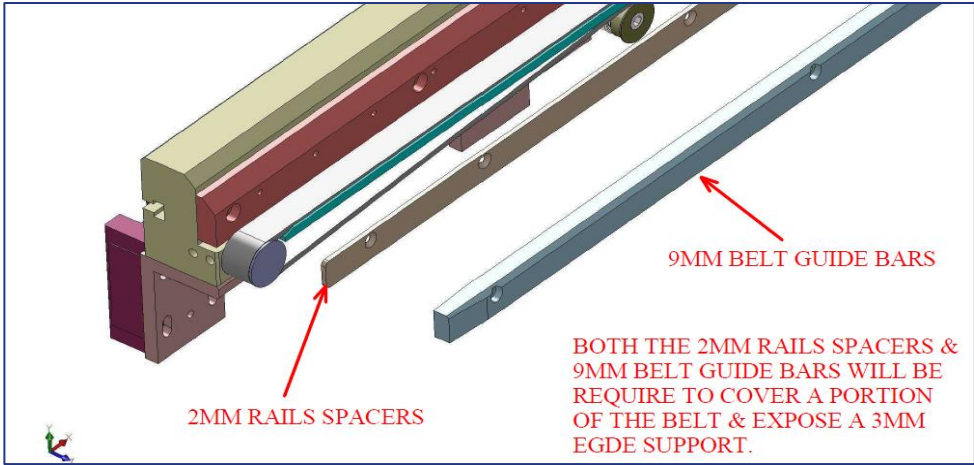
The 4-module inline In-circuit tester (ICT) conveyor belt guide bar used to manage the conveyor belt exposure to support 3mm, 5mm and 10mm (Figure 2 - 4) of printed circuit board edge.

Figure 2: 3mm board edge support

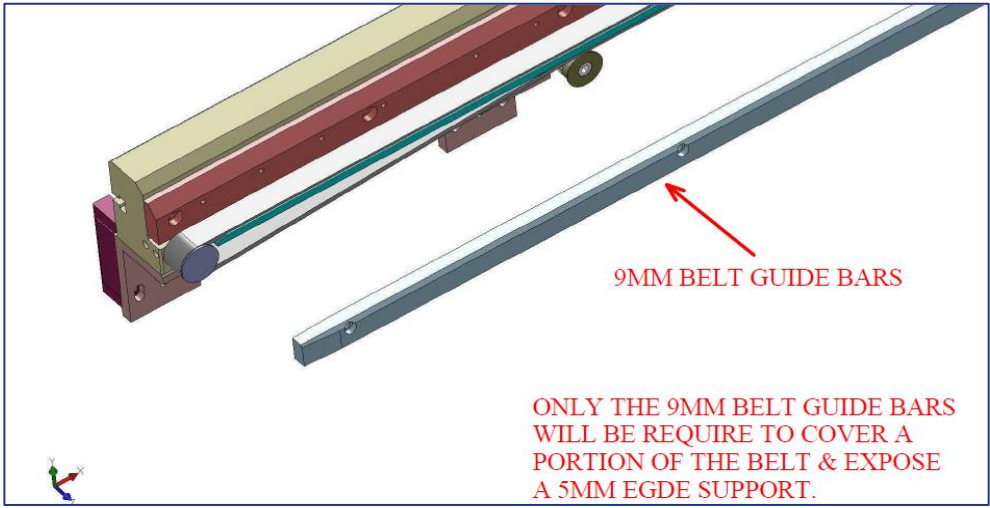
Figure 3: 5mm board edge support

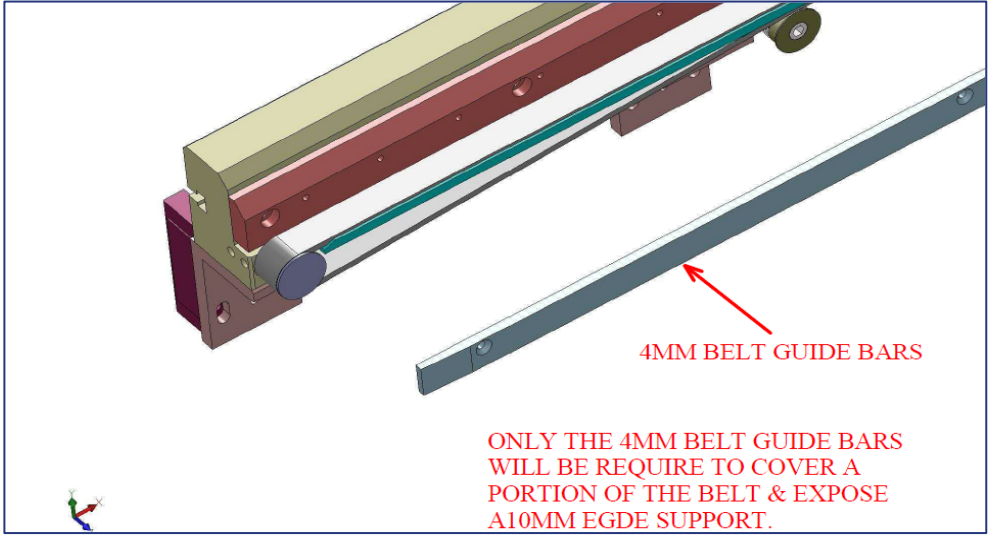
Figure 5: 10mm board edge support
