S E R V I C E N O T E

37717C PDH/SDH/Jitter Test Set

Instrument Fails to Download Firmware via Floppy disk

DATE: March 1997

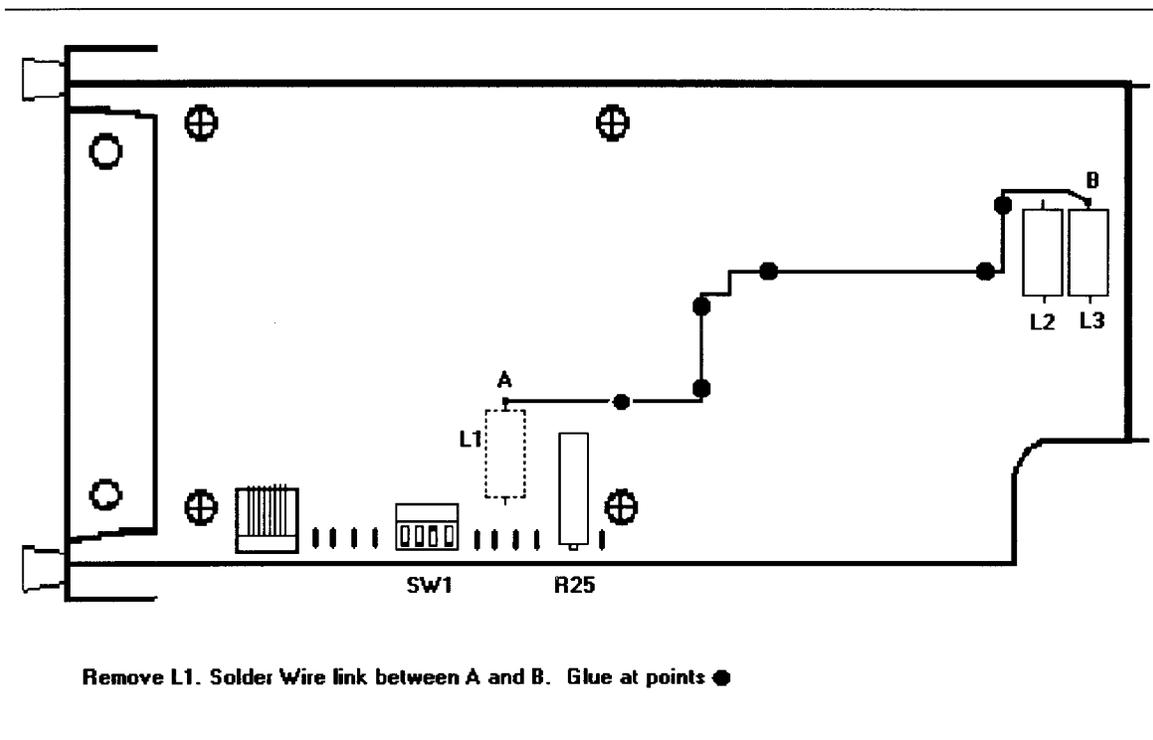
Figure 2 - Showing the Wire-Link modification to the Processor Board

These problems are due to insufficient RFI screening on the new version of disk drive introduced at BS2:23. Improved screening was introduced into production units at BS2.41.

A wire-link modification to the processor PCB to improve the stability of the disk-drive supply voltage should also be done on these units. This modification was introduced at BS 2:65.

1. Remove the processor module as described above.
2. Remove L1 and discard - see Figure 2..
3. Solder a wire link on the topside of the board as shown in Figure 2.
4. Using an epoxy resin glue, support the wire link at the points shown in Figure 2.
