S E R V I C E N O T E

37732A Telecom/Datacom Analyzer**Serial Numbers:** 3XXXXU00000 / 9999U99999**Electromagnetic Interference on the 37732A Datacom Interfaces.****Parts Required:** P/N 8159-0005 0 ohm resistor Qty 3**Situation:**

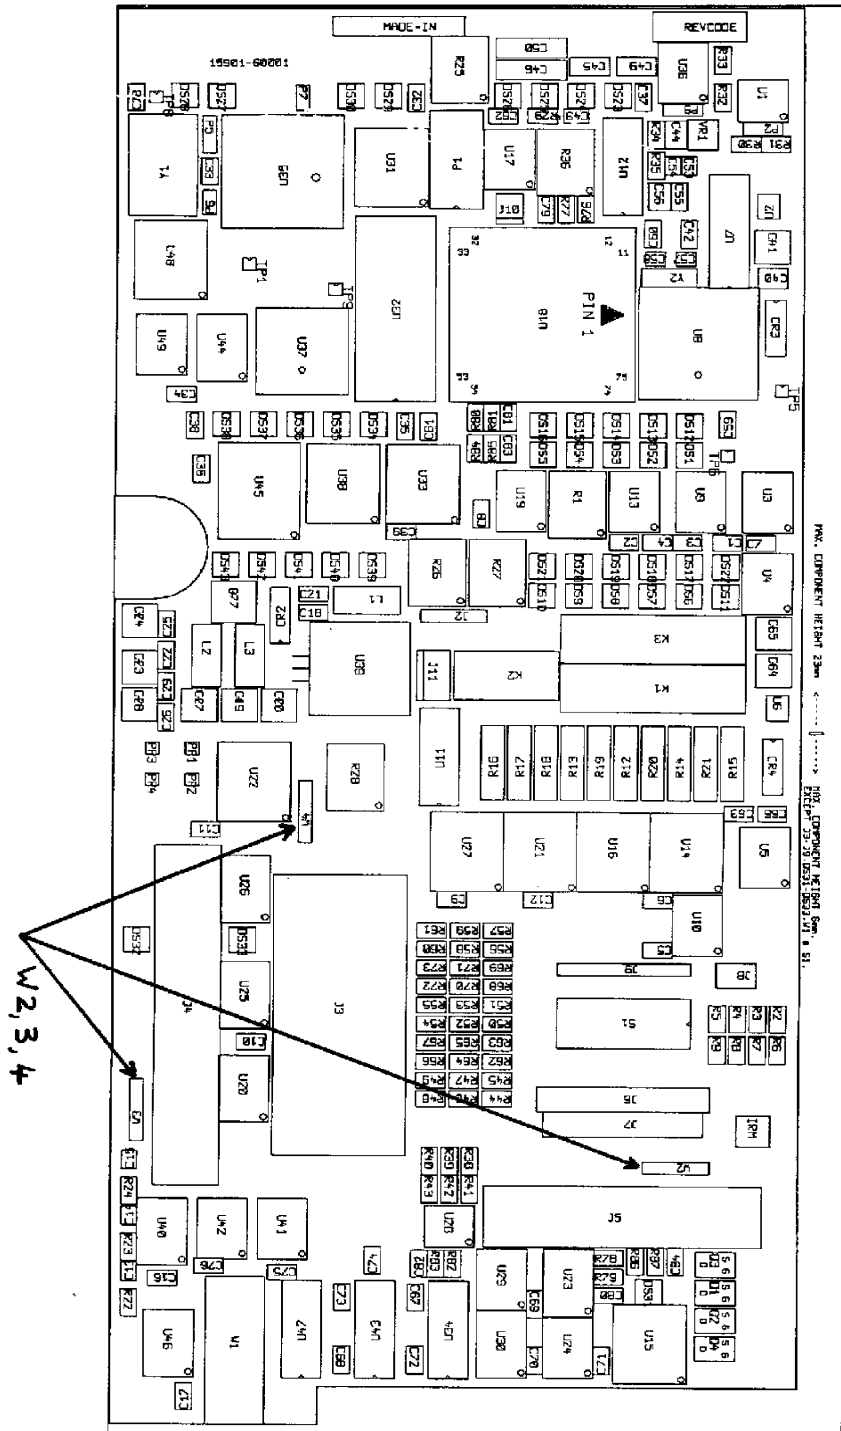
A Sync Loss condition may occur when the 37732A is being operated in Datacom mode. The Sync Loss is due to bit errors which are caused by Electromagnetic Interference “pick-up” at the RS-232/V.24, V.35 and RS-449/V.11 Datacom Interfaces. The Electromagnetic Interference is being radiated from the 2Mbit/s signal at the 37732A Signal In port. The problem is caused by bad continuity between the Chassis ground and the pcb ground connection at the Datacom Interfaces.

To improve the continuity between Chassis ground and the pcb ground, a modification has now been made to the 37732A Datacom Module. A 0 ohm resistor has been fitted between the Chassis ground and the pcb ground connections at the RS-232/V.24, V.35 and RS-449/V.11 Datacom Interfaces. The 0 ohm resistors, p/n 8159-0005, are inserted into link positions labeled W2, W3 and W4 on the Datacom Module pcb Assembly. Refer to Figure 1 for the locations of W2, W3 and W4. Refer to Section G9-8 of the 37732A Service Manual, p/n 37722-90001, for information on accessing the Datacom Module pcb Assembly for modification.
