S E R V I C E N O T E

HP 4145B Semiconductor Parameter Analyzer

Serial Numbers: 2830J00100 2830J02933

SMU Board Modification

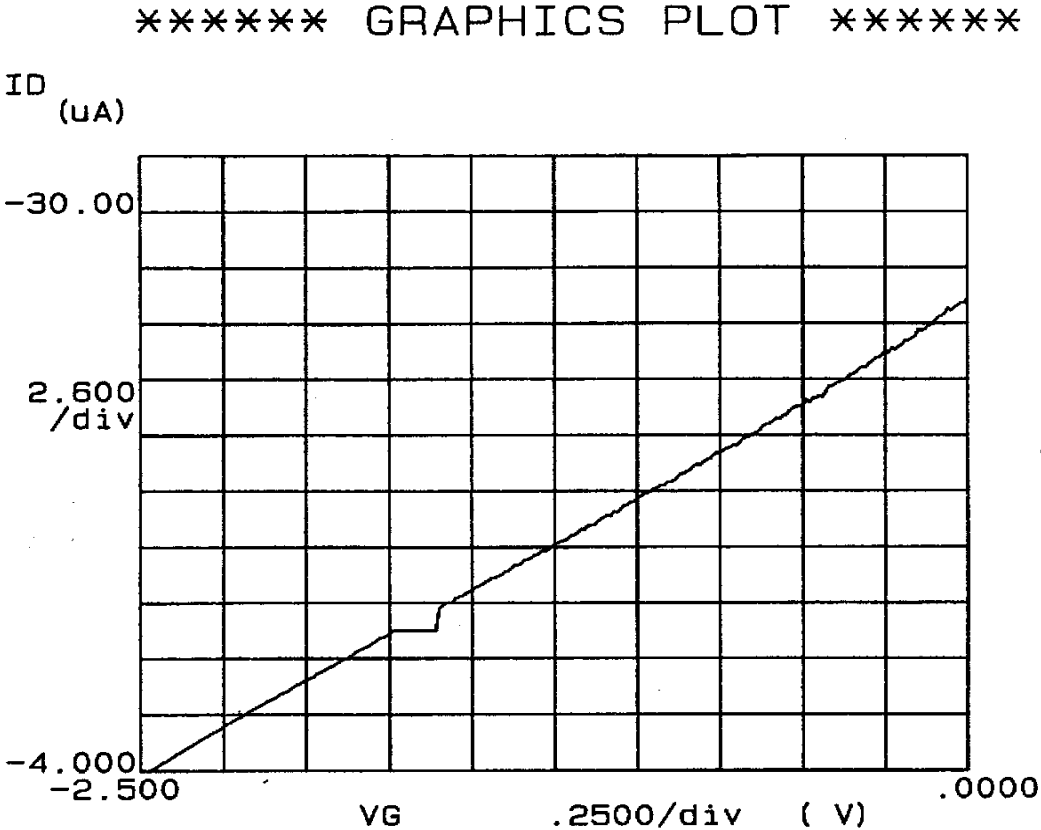
Figure 1. A Current Measurement Example

When measuring currents, an SMU may generate a dip spike, if a range change occurs. Figure 1 shows an example of this occurrence.
