S E R V I C E N O T E

Agilent 43521A Downconverter Unit

Serial Numbers: JP1KG00101 / JP1KG00158

DATE: September 2000

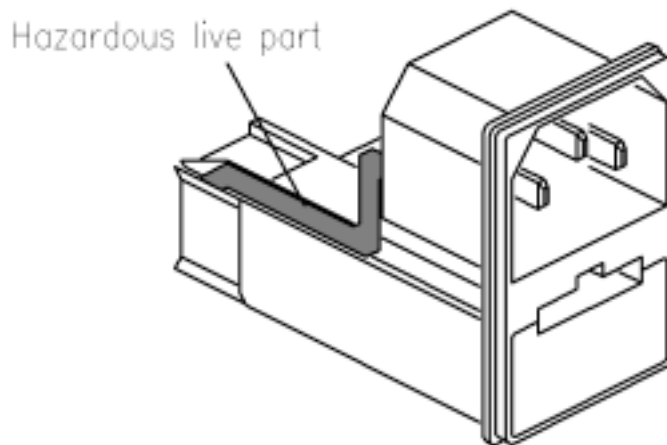
Figure 1. AC Inlet Connector

The AC inlet (P/N 1252-6951) has the potential to slip out of the instrument's rear panel slot if the AC power cord is forcefully pulled in a diagonal direction. When this happens, an exposed connection on the AC inlet module may touch the rear panel of the instrument and cause an electrical short if the AC power cord is still connected to the AC power outlet. See Figure 1.

In the worst case, there is also a possibility of an electric shock hazard to the user if the user completes a circuit between the instrument panel and another grounded connection while the AC power cord is still connected to the AC power outlet.

Solution 1. AC Inlet Still Intact.

- Remove the AC power cable from the AC power outlet and the product.
- Remove the top, bottom, and side covers.
- Seal the hot line terminal on the AC inlet with silicon paste (P/N 5183-4112).
- Reinforce the connection between the AC inlet and the rear panel with silicon paste.
- No adjustments and performance tests are required after this modification.
