44474A-01A

S E R V I C E N O T E

April 28, 2008

Defective connectors shipped with 44470A, 44471A, 44473A, 44474A

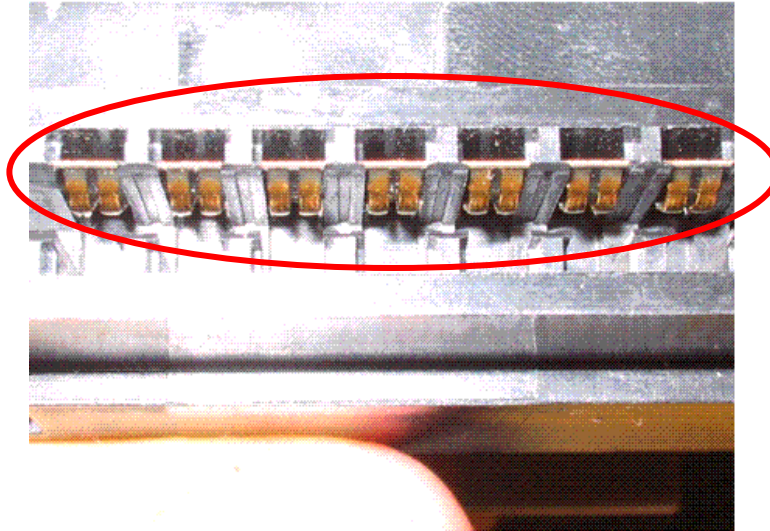
The 44470A, 44471A, 44473A, and 44474A contain a main relay card and a removable screw terminal block (see Figure 1). Some of the removable terminal blocks that were shipped between 1-Jan-2008 and 08-April-2008 have a defective connector that results in half of the pins being unconnected.

Figure 3: Defective Connector with all pins on one side

The procedure to correct the defective connectors is very simple. One must replace the defective connector with a good connector (see connector part numbers list on page 2). The customer may perform this procedure or have an Agilent-qualified person perform this procedure.

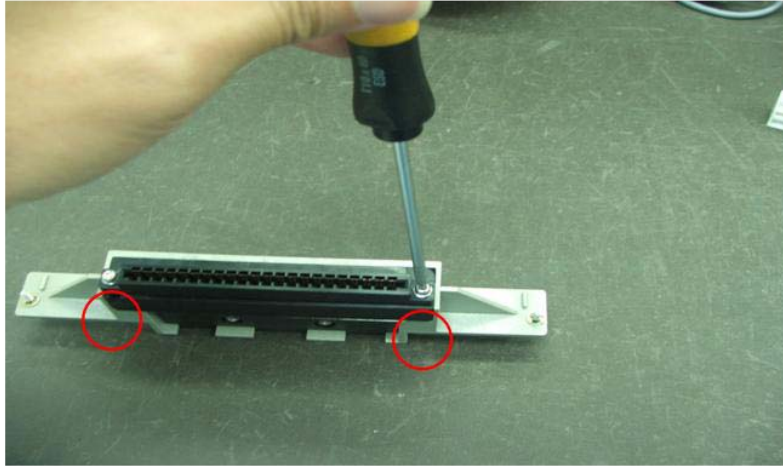
Figure 4: Removing defective connector from terminal block

Connector Replacement Procedure: After identifying a defective connector, the connector in the terminal block is repaired by removing the two screws that hold the connector to its case. Note the orientation of the connector. This will release the connector from the terminal block and then a good one can replace it. No soldering is necessary. See Figure 4.

1. Use a T10 torx driver to unscrew the 2 screws of the connector.

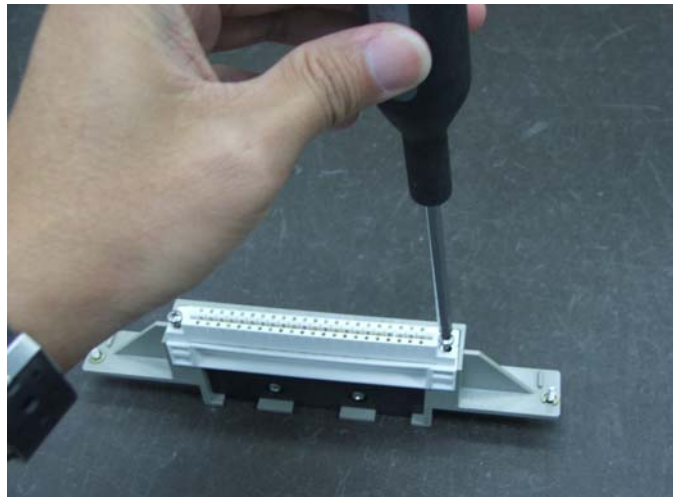
Figure 5: Good Connector attached to terminal block

Use the same torx driver to screw on the good connector, using the same orientation at the connector you just removed (see Figure 5).
