## S E R V I C E N O T E

**44477A Form C Relay**

**44487A Terminal Block shipped with 44477A Relay Module used with Agilent 3499A/B or 3488A Switch Systems.**

**WARNING****Possible Shock Hazard**

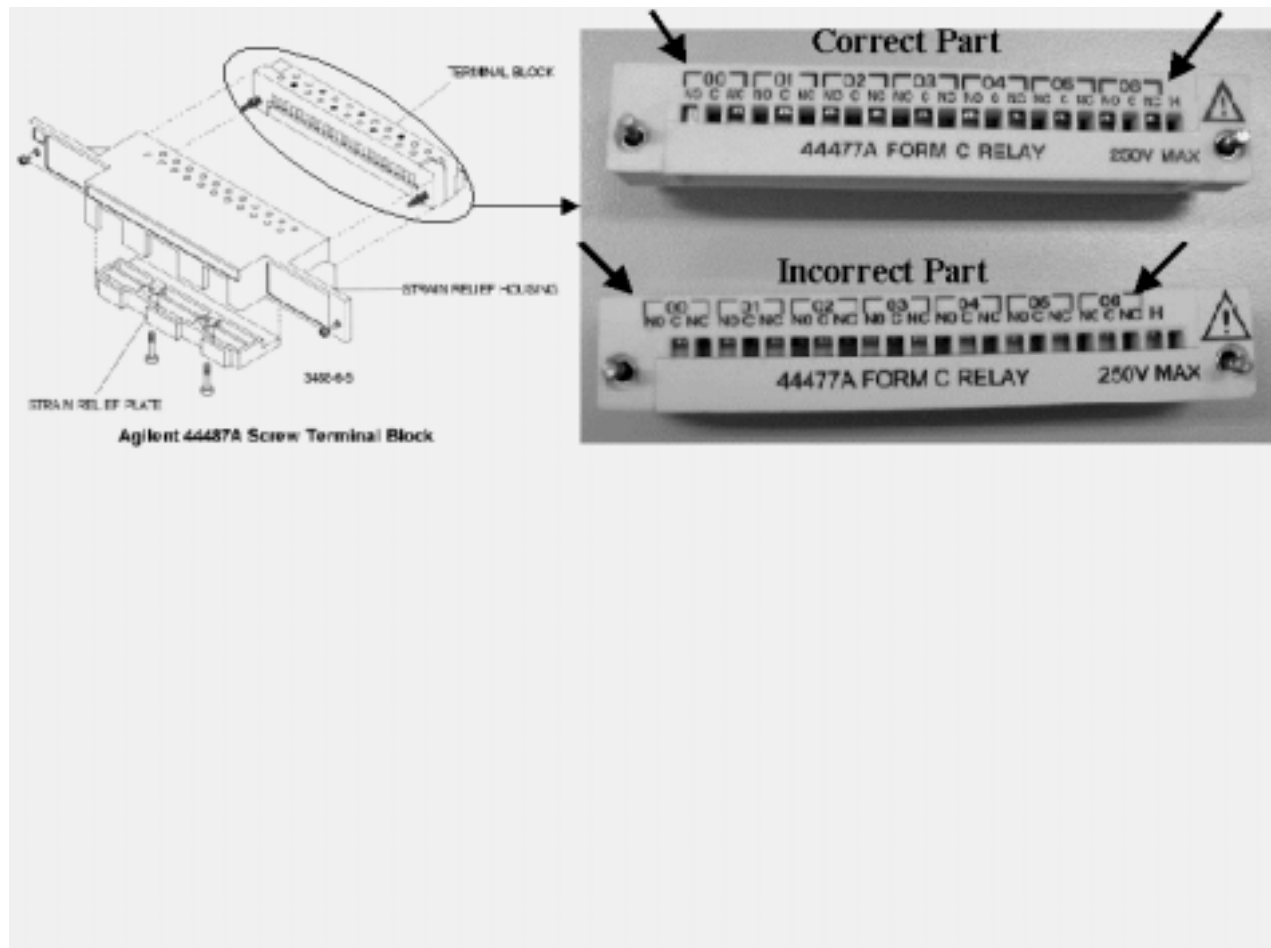
**Figure 1. Picture of the Terminal Block**

Some Agilent 44487A Terminal Blocks shipped with Agilent 44477A Relay Modules have incorrect silkscreen printing. On the incorrect terminal blocks the silkscreen printing is shifted from the correct position. The silkscreen printing on correct parts should correspond to the connector holes. Please see the below photo.

Agilent will replace the incorrect Terminal Block (44487A) with a correct one.
