S E R V I C E N O T E

**4957A Protocol Analyzer**

**Serial Numbers:** 3125A00000 / 3125A00393

**DLC Data Bus Contention Problem / A1UT4**

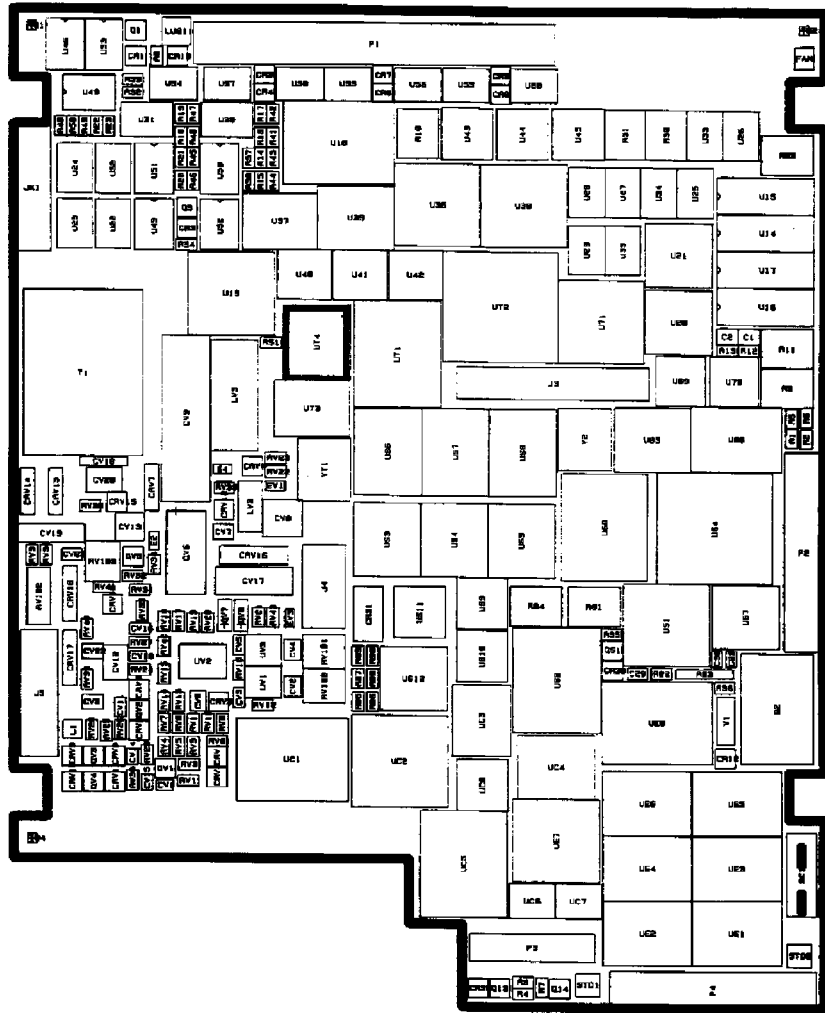
A data bus contention problem exists in the program of ROM, A1UT4. This ROM is used in the DLC circuitry on the main assembly of the 4957A. Possible symptoms will be DLC errors at either power-on or when the self-test loop is run.

The ROM, A1UT4, has been reprogrammed to fix this data bus contention problem. Using Figure #1, remove ROM UT4 from its socket, noting the ROM's orientation in the socket. Place the new ROM, p/n 04957-19015, in the socket. After replacing the ROM, run the self-test for 5-10 loops.
