4980A-11

S E R V I C E N O T E

HP 4980A Network Advisor

Monochrome LED Board Modification (NOT Color)

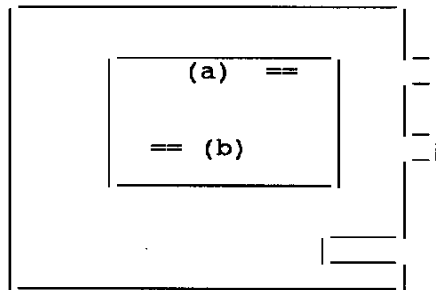
When new monochrome assembly 5063-1880 is required to replace the older 5062-9677 display, the LED board must be modified. The modification will allow a greater range of brightness adjustment.

Jumper locations
(a) or (b) is on
the small board.

3. Carefully snap out LED display board assembly
4. Locate jumper and remove at one of either location as shown in the diagram

5. Reinstall wires/fasteners and board assembly
6. Test brightness operation
