4981A-11

S E R V I C E N O T E

HP 4981A Network Advisor

Monochrome LED Board Modification (NOT Color)

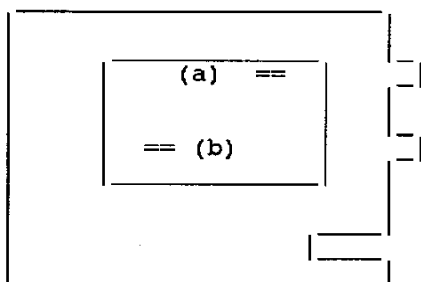
When new monochrome assembly 5063-1880 is required to replace the older 5062-9677 display, the LED board must be modified. The modification will allow a greater range of brightness adjustment.

Jumper locations  
(a) or (b) is on  
the small board.

3. Carefully snap out LED display board assembly
4. Locate jumper and remove at one of either location as shown in the diagram

5. Reinstall wires/fasteners and board assembly
6. Test brightness operation
