4982A-11

S E R V I C E N O T E

HP 4982A Network Advisor

Monochrome LED Board Modification (NOT Color)

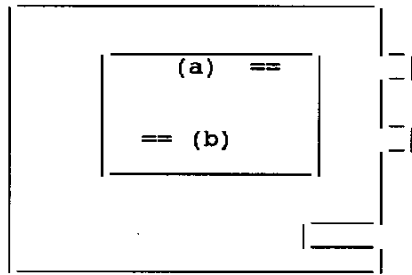
When new monochrome assembly 5063-1880 is required to replace the older 5062-9677 display, the LED board must be modified. The modification will allow a greater range of brightness adjustment.

Jumper locations
(a) or (b) is on
the small board.

3. Carefully snap out LED display board assembly
4. Locate jumper and remove at one of either location as shown in the diagram

5. Reinstall wires/fasteners and board assembly
6. Test brightness operation
