Supersedes:
None**HP MODEL 5345A ELECTRONIC COUNTER****All Serial Prefixes****FAILURE TO RESPOND PROPERLY TO A SERIAL POLL
BY A SERIES 200 CONTROLLER**

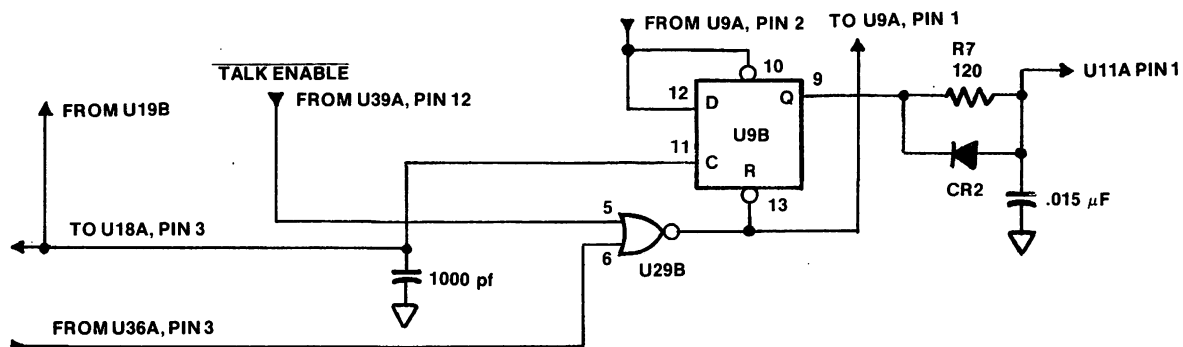
A race condition is set up at the clock (pin 11) and reset (pin 13) inputs to U9B on the A12 board. Clocking must occur after the reset signal for the proper logic levels to drive U11A which eventually drives the DAV line via U9A. Both the clock and reset inputs to U9B are derived from the ATN signal. A 1000 pf capacitor, HP Part Number 0160-4040 should be connected from pin 11 of U9B to pin 7 of U9B in order to delay the clock until after the reset has occurred.

This is how the modification appears on the schematic of the A12 board:
