**6572A-05A**

**S E R V I C E N O T E**

**6572A DC POWER SUPPLY MANUALLY CONTROLLED**

**The Current Shunt (Circuit Reference “R407” may have intermittent sense wires, which may cause Instability of Current regulation, Current read back and Current programming.**

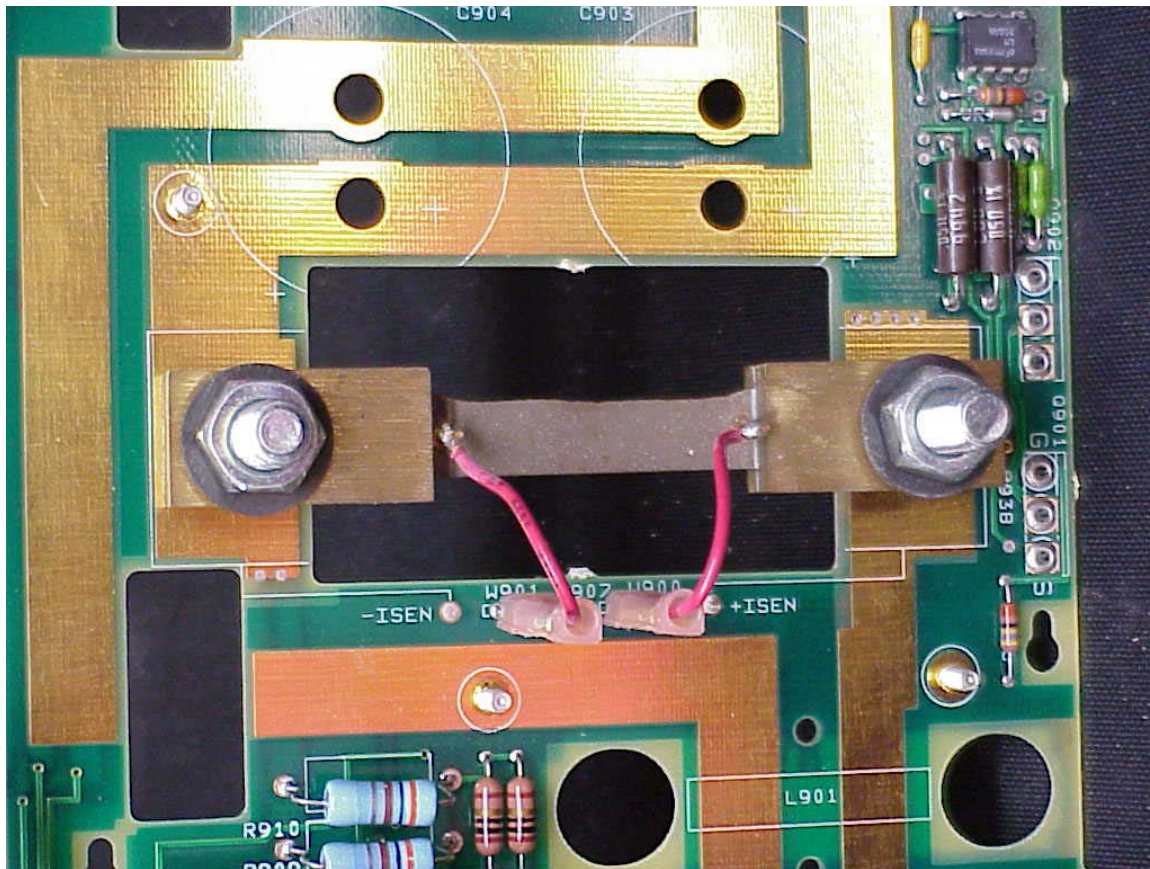
When the push-on connectors become intermittent the output current will become unstable. Loose push-on connectors can cause the output current to change dramatically. The current can change from any set current, and may go to the maximum rated output current of the instrument.

This picture shows how the Shunt R907 is connected using the term-crimp connectors.

The Shunt R907 is connected to "W900" & "W901"

Cut the terminal-crimp connectors off of both wires and discard the connectors. Make this cut as close to the terminal-crimp connector as possible. The required strip length should be 5mm. This strip length will be used to prevent the wire length being too long and shorting to the instrument chassis. If replacement of this wire is required any color (22 AWG, 300V 105C) wire type can be used.

This modification can be done from the top of the board. Carefully strip and solder the wires, and avoid burning the wire insulation and the printed circuit board.
