6572A-09

S E R V I C E N O T E

6572A DC POWER SUPPLY, 0-20V, 0-100 A, 2000 W. MANUALLY CONTROLLED.

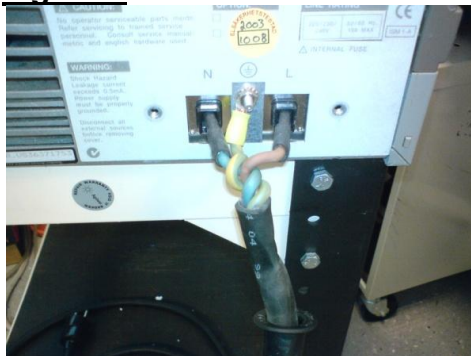
Figure 1 is an example of what happens when the strain relief becomes loose, the line cord becomes twisted. When a heavy line cord is used the strain relief becomes loose very easily, and the line cord cable can rotate freely.

The entire AC **INPUT SAFETY COVER** P/N 5040-1676 should be replaced.

The line cord should also be securely fastened at a point 6 to 12 inches away from **INPUT SAFETY COVER** as shown in [Figure 7](#). When this type of strain relief is used the electrical code requires the cord/cable being held by the strain relief be secured. Doing this eliminates the cable or cord from being twisted as shown in figure 1.

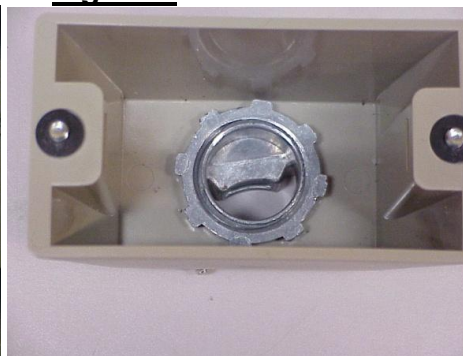
Figure 2 shows the inside of the AC Safety Cover housing the incorrect hardware is shown. It will be very difficult to tighten the strain relief. AMC (Asian Manufacturing Center) uses a special tool to tighten the locking nut. When the incorrect nut is used or a locking Nut is put on incorrectly the strain relief will become loose as described above.

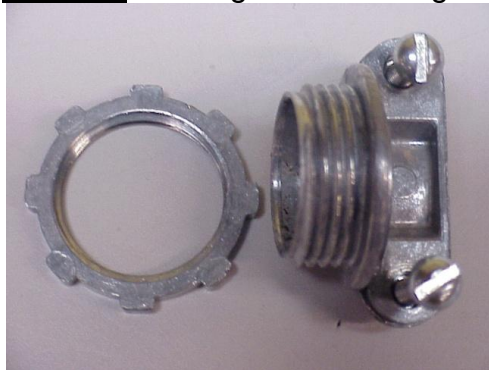
Figure 3 Regal Non locking Nut

Figures 3 & 5 is representative of a not without locking ribs.

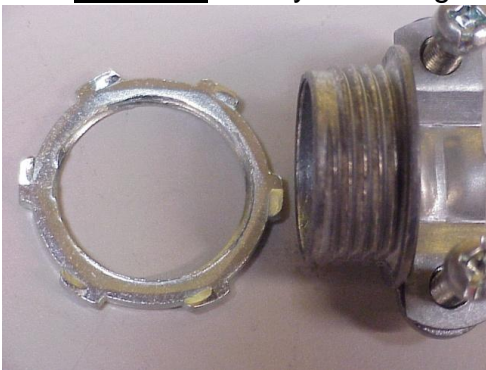
Figure 4 Heyco locking Nut

Figures 4 & 6 is representative of a nut with locking ribs.

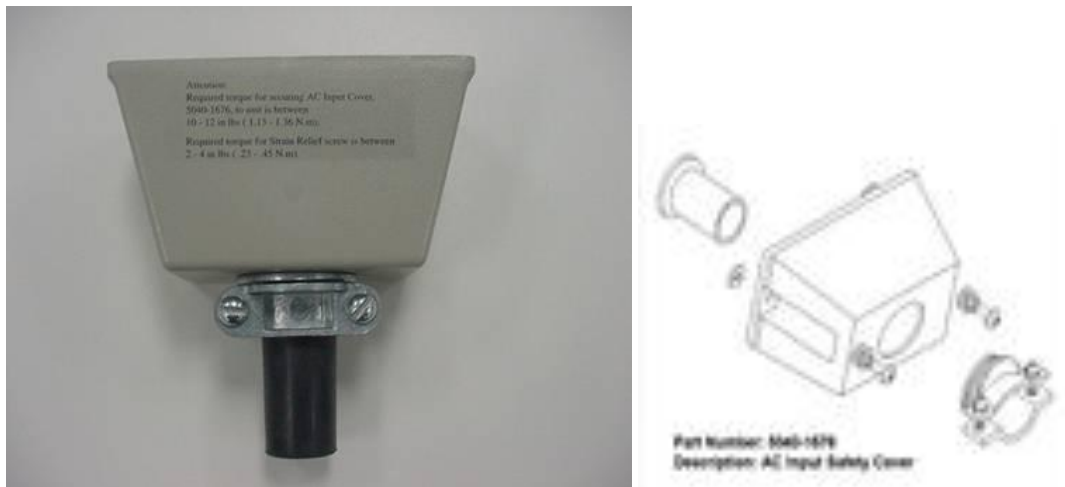
The individual parts shown in [Figure 8](#) are not available from Agilent parts “SPO” (Support Parts Organization). It is not cost affective to repair the AC **INPUT SAFETY COVER**, a special tool is required to tighten the nut shown in Figure 2.

Required torque for securing AC Input Cover,
5040-1676, to unit is between
10 - 12 in lbs (1.13 - 1.26 N.m).

Required torque for Strain Relief screw is between
tightened using 2inlb torque.

ONLY replace the AC Safety Cover P/N 5040-1676 if the label shown in Figure 8 does not appear on the Safety cover or if the Cover is defective due to described failure, the Safety cover should be replaced at **NO** charge to the customer.
