6573A-07

**S E R V I C E N O T E**

**6573A - DC POWER SUPPLY, 0-35 V, 0-60 A, 2100 W.  
MANUALLY CONTROLLED**

**The four filter capacitors circuit reference (C416-C419) on the A4 AC input board starts leaking electrolyte**

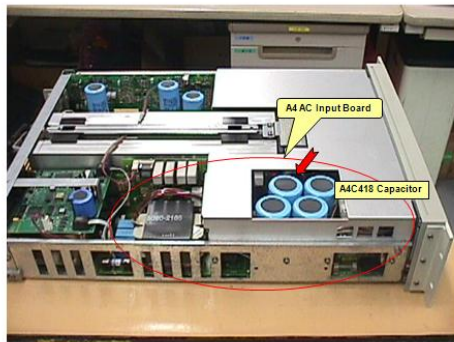
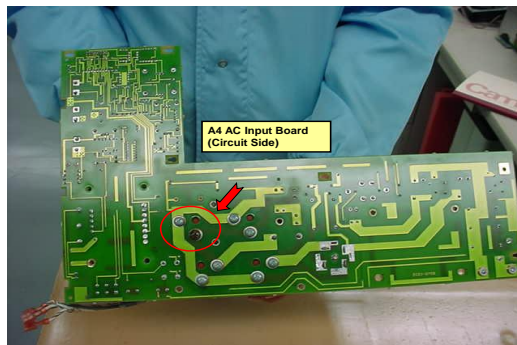
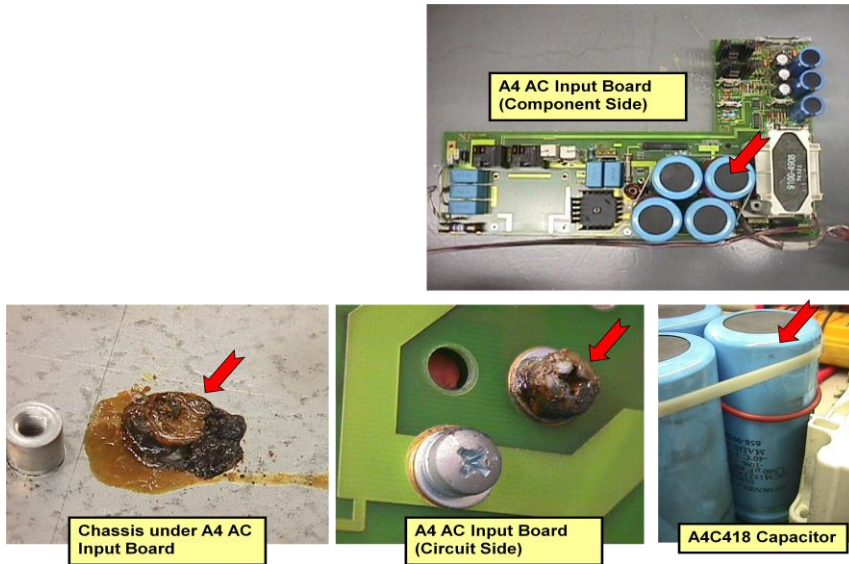
The four filter capacitors circuit reference (C416-C419) on the A4 AC input board starts leaking electrolyte - not through the pressure valve in the bottom as one would expect but through one of the terminal screw bushings.”

The screw P/N 2680-0217 length currently being used was not considered and the length was overlooked. The screw length is 0.375 inches long. We have found that the screw can be 0.055 inches too long and may bottom out causing the tapped hole in the header of the capacitor to become cracked or become broken.

When this happens the electrolyte will slowly leak out over time, and cause the defect described. This situation is even worse due to the capacitor is mounted with the header face down. If the capacitor was mounted header face up a cracked or broken header would not have caused this problem, the electrolyte could not leak out.

1. All affected models and tested assemblies WIP (Work In Process), FGI (Finished Goods Inventory) at SPO (Support Parts Organization) & AMC (Asian Manufacturing Center) has been inspected for capacitors with damaged headers due to the incorrect screw
2. When this repair is being done all of the hardware described above should be replaced (It is NOT recommended that any of the hardware be reused)
3. The following figures can be used when doing the repair.
4. Inspect the assembly as described below.
5. The last figure will aid in the reassembly of the hardware and the capacitors.
