6573A-08

S E R V I C E N O T E

6573A DC POWER SUPPLY, 0-35 V, 0-60 A, 2100 W. MANUALLY CONTROLLED.

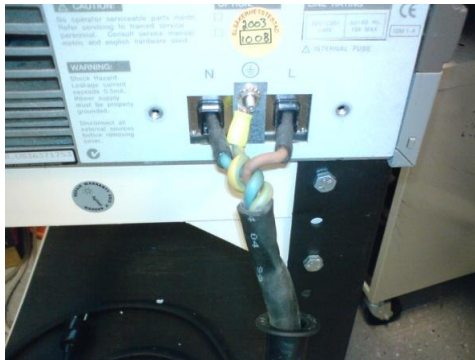
Figure 1 is an example of what happens when the strain relief becomes loose, the line cord becomes twisted. When a heavy line cord is used the strain relief becomes loose very easily, and the line cord cable can rotate freely.

The entire AC **INPUT SAFETY COVER** P/N 5040-1676 should be replaced.

The line cord should also be securely fastened at a point 6 to 12 inches away from **INPUT SAFETY COVER** as shown in [Figure 7](#). When this type of strain relief is used the electrical code requires the cord/cable being held by the strain relief be secured. Doing this eliminates the cable or cord from being twisted as shown in figure 1.

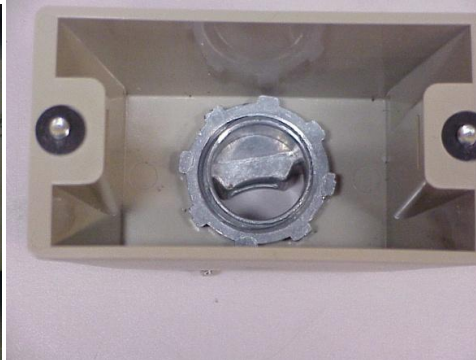
Figure 2 shows the inside of the AC Safety Cover housing the incorrect hardware is shown. It will be very difficult to tighten the strain relief. AMC (Asian Manufacturing Center) uses a special tool to tighten the locking nut. When the incorrect nut is used or a locking Nut is put on incorrectly the strain relief will become loose as described above.

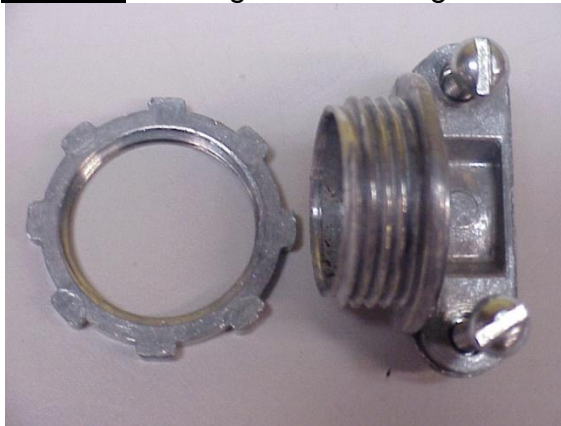
Figure 3 Regal Non locking Nut

Figures 3 & 5 is representative of a not without locking ribs.

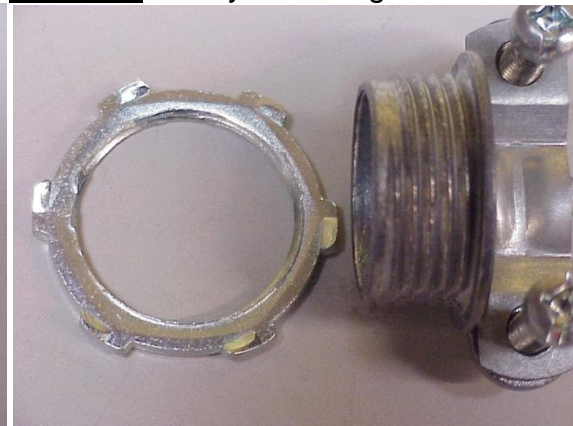
Figure 4 Heyco locking Nut

Figures 4 & 6 is representative of a nut with locking ribs.

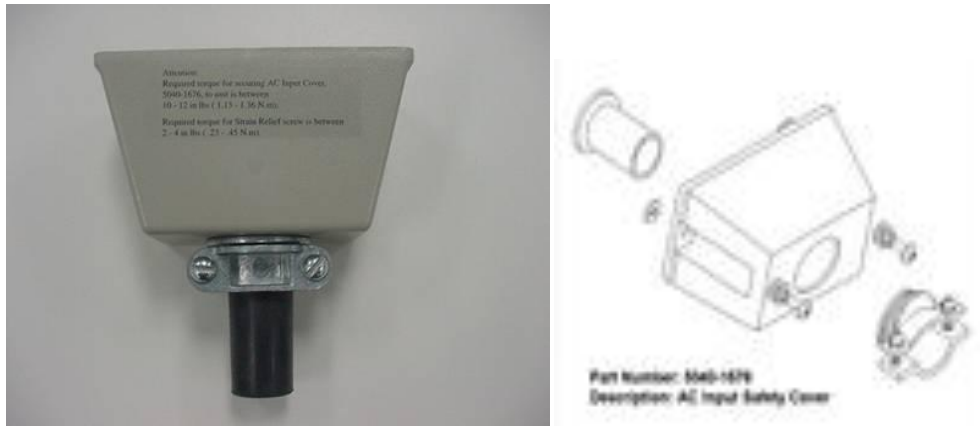
Figure 8

The individual parts shown in [Figure 8](#) are not available from Agilent parts “SPO” (Support Parts Organization). It is not cost affective to repair the AC **INPUT SAFETY COVER**, a special tool is required to tighten the nut shown in Figure 2.

The information below is what is printed on the label shown in **Figure 8**

Required torque for securing AC Input Cover,
 5040-1676, to unit is between
 10 – 12 in lbs (1.13 – 1.26 N.m).

Required torque for Strain Relief screw is between
 tightened using 2inlb torque.

ONLY replace the AC Safety Cover P/N 5040-1676 if the label shown in [Figure 8](#) does not appear on the Safety cover or if the Cover is defective due to described failure, the Safety cover should be replaced at **NO** charge to the customer.
