6574A-10

S E R V I C E N O T E

6574A DC POWER SUPPLY, 0-60 V, 0-35 A, 2100 W. MANUALLY CONTROLLED.

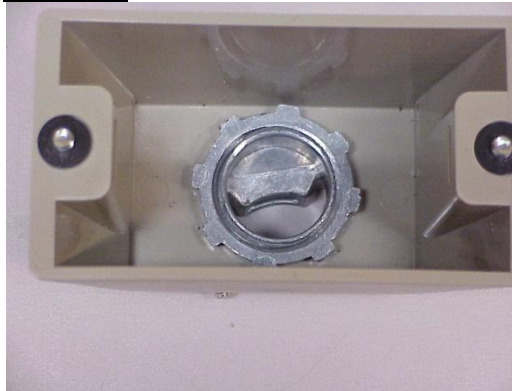
Figure 2 shows the inside of the AC Safety Cover housing the incorrect hardware is shown. It will be very difficult to tighten the strain relief. AMC (Asian Manufacturing Center) uses a special tool to tighten the locking nut. When the incorrect nut is used or a locking Nut is put on incorrectly the strain relief will become loose as described above.

The entire AC **INPUT SAFETY COVER** P/N 5040-1676 should be replaced.

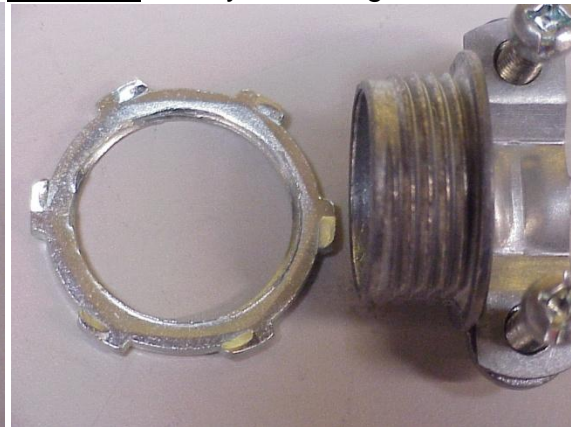
Figure 4 Heyco locking Nut

Figures 4 & 6 is representative of a nut with locking ribs.

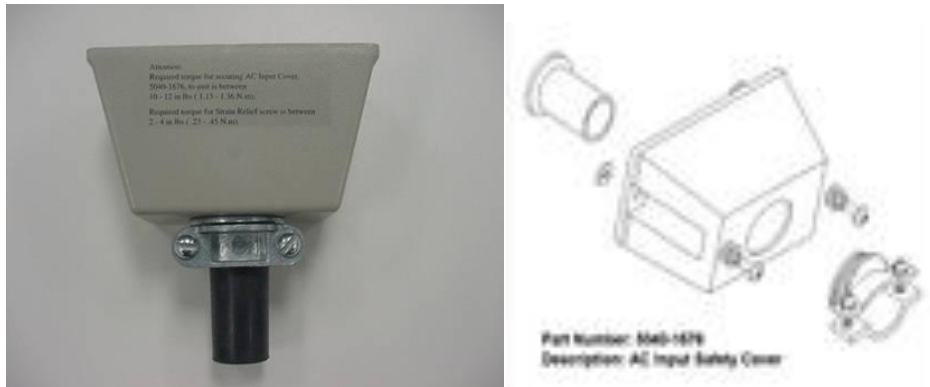
Figure 8

The individual parts shown in **Figure 8** are not available from Agilent parts “SPO” (Support Parts Organization). It is not cost affective to repair the AC **INPUT SAFETY COVER**, a special tool is required to tighten the nut shown in Figure 2.

The information below is what is printed on the label shown in **Figure 8**

Required torque for securing AC Input Cover,
5040-1676, to unit is between
10 – 12 in lbs (1.13 – 1.26 N.m).

Required torque for Strain Relief screw is between
tightened using 2inlb torque.

ONLY replace the AC Safety Cover P/N 5040-1676 if the label shown in Figure 7 does not appear on the Safety cover or if the Cover is defective due to described failure, the Safety cover should be replaced at **NO** charge to the customer.
