6575A-07A

S E R V I C E N O T E

6575A DC POWER SUPPLY MANUALLY CONTROLLED

**Serial Numbers: US36340097/US36340297 & MY41000101/MY41000216 &
SG41000101/ SG41000134**

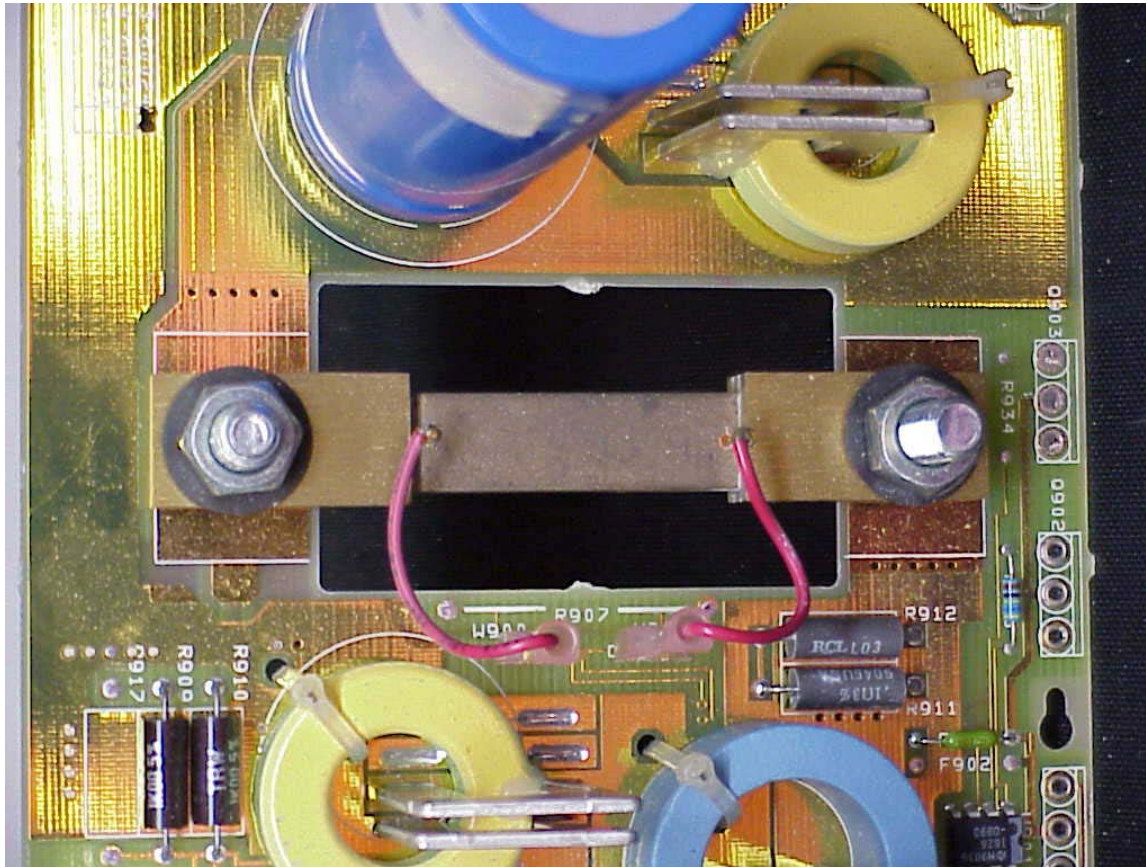
The Current Shunt (Circuit Reference “R907”) may have intermittent sense wires, which may cause Instability of Current regulation, Current read back and current programming.

When the push-on connectors become intermittent the output current will become unstable. Loose push-on connectors can cause the output current to change dramatically. The current can change from any set current, and may go to the maximum rated output current of the instrument.

This picture shows how the Shunt R907 is connected using the term-crimp connectors.

The Shunt R907 is connected to "W900" & "W901"
