6575A-09

S E R V I C E N O T E

**6575A - DC POWER SUPPLY, 0-120 V, 0-18 A, 2160 W.
MANUALLY CONTROLLED**

Serial Numbers: MY41000101/ MY41000318 SG41000101/ SG41000194

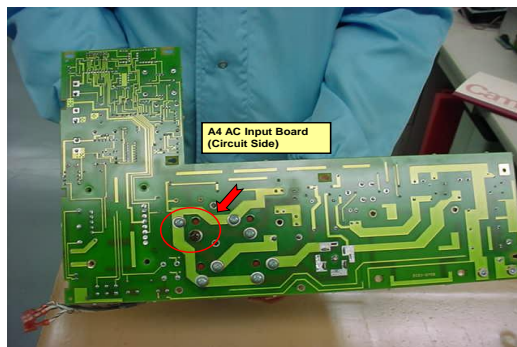
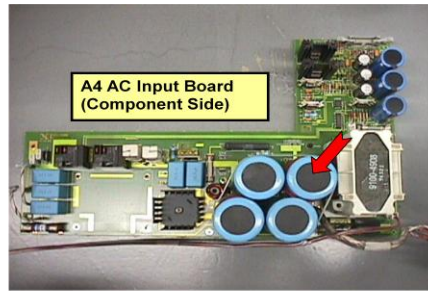
The four filter capacitors circuit reference (C416-C419) on the A4 AC input board starts leaking electrolyte - not through the pressure valve in the bottom as one would expect but through one of the terminal screw bushings.”

The screw P/N 2680-0217 length currently being used was not considered and the length was overlooked. The screw length is 0.375 inches long. We have found that the screw can be 0.055 inches too long and may bottom out causing the tapped hole in the header of the capacitor to become cracked or become broken.

When this happens the electrolyte will slowly leak out over time, and cause the defect described. This situation is even worse due to the capacitor is mounted with the header face down. If the capacitor was mounted header face up a cracked or broken header would not have caused this problem, the electrolyte could not leak out.

1. All affected models and tested assemblies WIP (Work In Process), FGI (Finished Goods Inventory) at SPO (Support Parts Organization) & AMC (Asian Manufacturing Center) has been inspected for capacitors with damaged headers due to the incorrect screw
2. When this repair is being done all of the hardware described above should be replaced (It is NOT recommended that any of the hardware be reused)
3. The following figures can be used when doing the repair.
4. Inspect the assembly as described below.
5. The last figure will aid in the reassembly of the hardware and the capacitors.
