66000A-06A

S E R V I C E N O T E

66000A DC Power Supply Main Frame

The instrument will not communicate or will not complete self test.

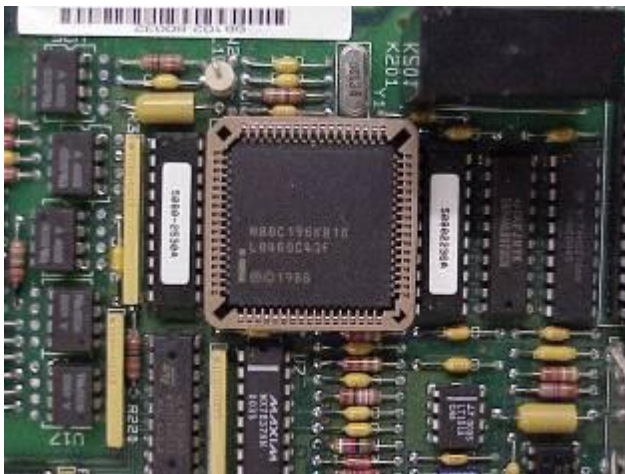
When the 16-Bit processor p/n1821-1474 is installed in the 68 pin PLCC SOCKET P/N 1200-1274 “U44” if there is not a gas tight connection between the processor pins and the socket pins an intermittent connection will occur.

The pin connections may not be reliable. Over time the pins may become intermittent which will cause the instrument not to communicate or not complete self test.

Figure 1 will help to identify the **68-PIN PLCC SOCKET location - P/N 1200-1274** (Circuit Reference “U44”)

Any Model having a serial number starting and ending with the serial numbers shown in the chart below should have the socket 68-PIN PLCC SOCKET - P/N 1200-1274 (Circuit Reference "U44") **REPLACED!**

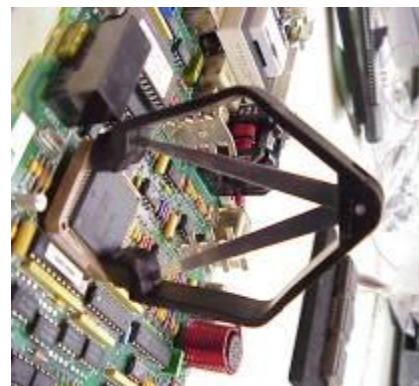
Figure 2

This picture shows the required tool used to remove the processor

Remove the 16-Bit processor p/n1821-1479 from the socket before the 68 pin PLCC socket p/n 1200-1274 is replaced.

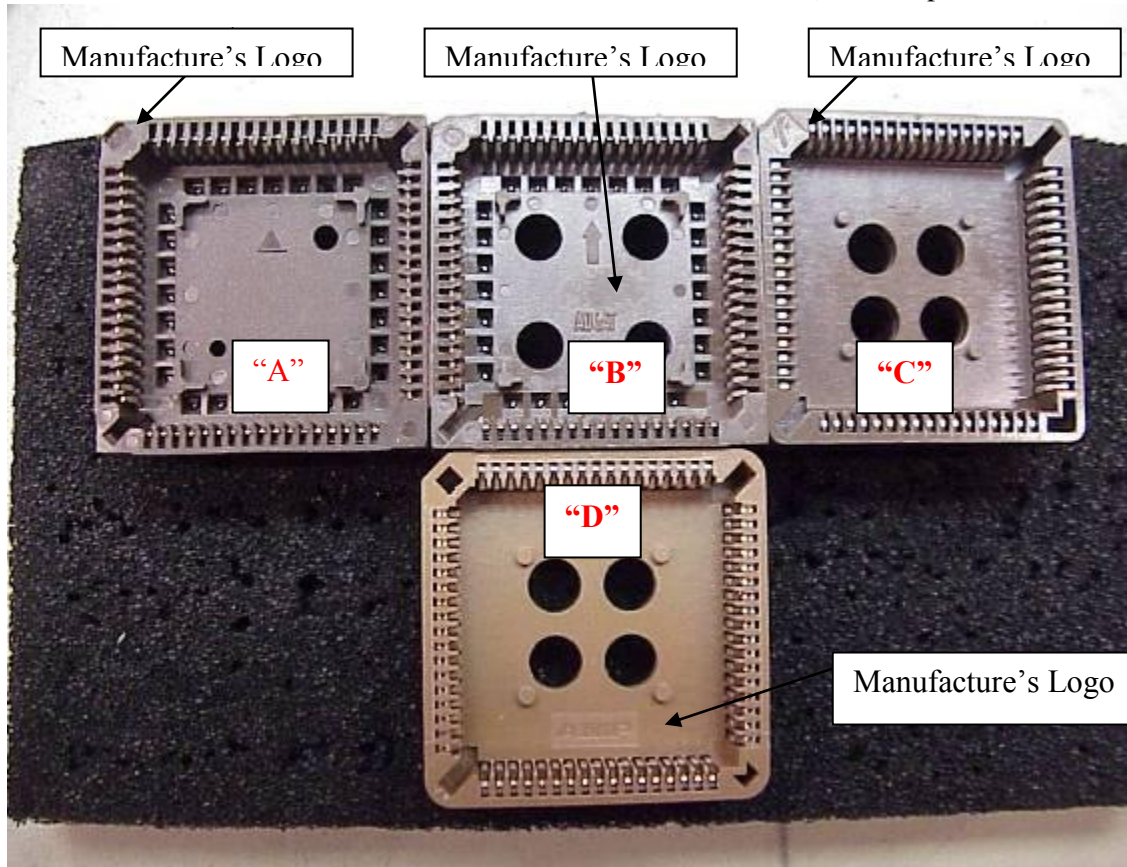
This figure should be used to identify **GOOD** sockets and a potential defective socket. The **16-Bit MCU 16 MHZ 68PLCC CMOS IC** (P/N 1821-1479) is **NOT** pictured.

- Socket **"A"** is a sample of a GOOD AMP socket.
- Socket **"B"** is a sample of a GOOD Tyco/Augit socket.
- Socket **"C"** is a sample of a GOOD FCI socket.
- Socket **"D"** is a sample of a DEFECTIVE Tyco socket.

The sockets above labeled **"A", "B" or "C"** are good and should NOT be replaced.
The socket above labeled **"D"** is considered defective should be replaced.

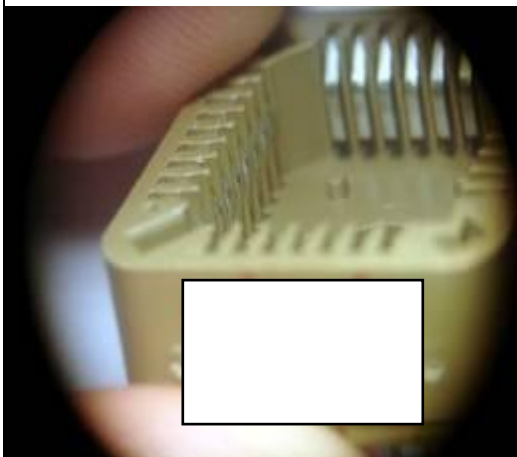
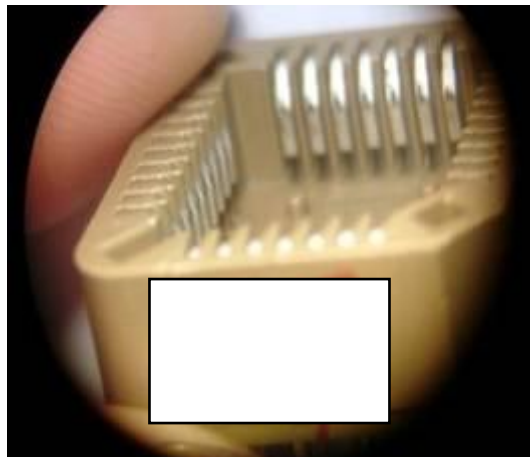
The effectiveness of this design enhancement was tested by comparing the mating and un-mating forces on the older and newer designs. The test results for sockets with the increased spring height (newer design) showed an increase in the mean mating force of 18.9% and an increase in the mean un-mating force of 23.4%. The increase in the un-mating force test results between the old design and the new design indicate that a greater normal force is being exerted on the test chip contacts by the socket contact beams. The two revisions of this contact beam design were visually examined after the mating and un-mating force testing. Photos of the two sockets are shown below. The photo on the left shows the older version socket prior to the enhanced contact beam design. The photo on the right shows a socket with the design enhancement. The contacts with the older design appear to be recessed farther into the housing after un-mating.
