66101A-09A

S E R V I C E N O T E

66101A DC Power Supply

The instrument will not communicate or will not complete self test.

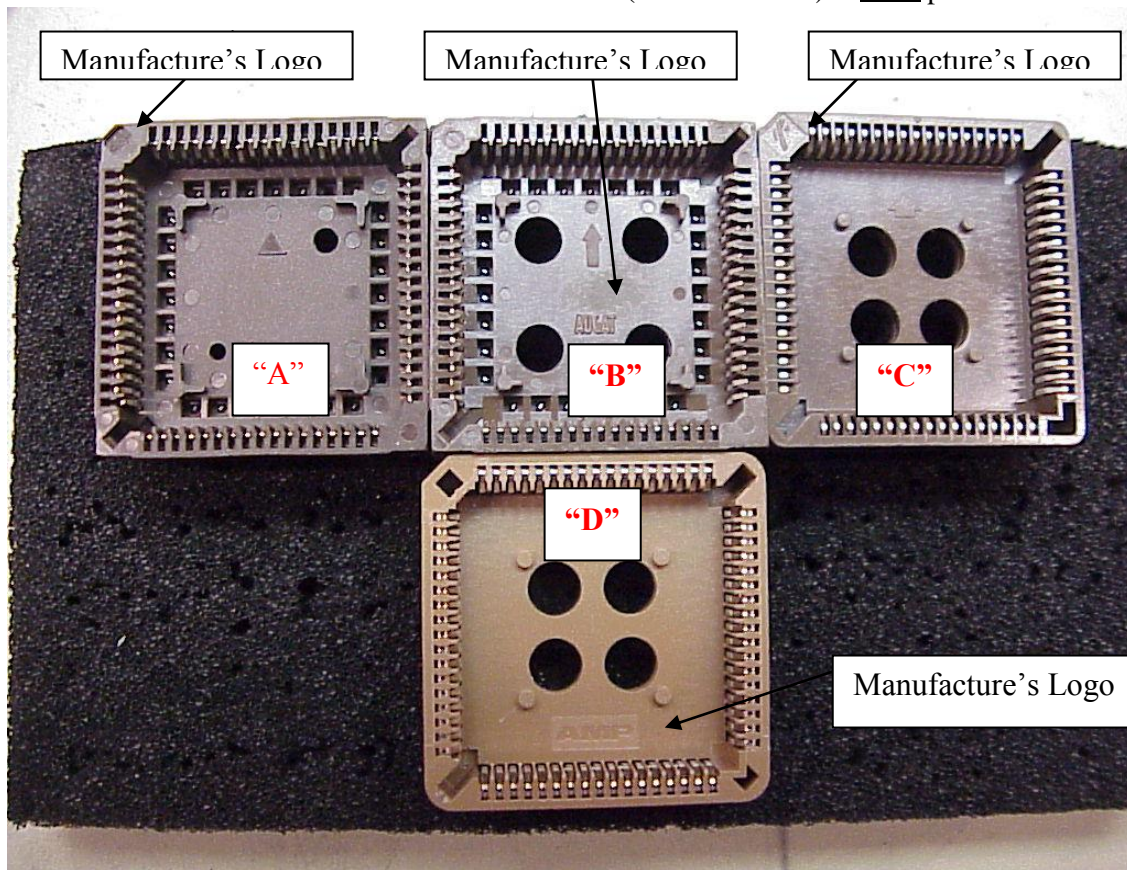
This figure should be used to identify **GOOD** sockets and a potential defective socket. The **16-Bit MCU 16 MHZ 68PLCC CMOS IC (P/N 1821-1479)** is **NOT** pictured.

The following information will help identify each socket type and manufacturer. The manufacturer's logo can be identified as shown. After the **16-Bit MCU 16 MHZ 68PLCC CMOS IC** has been removed there are also mold markings that can be easily viewed these markings should be used to identify a **Good or Defective socket**.

- Socket **"A"** is a sample of a GOOD AMP socket.
- Socket **"B"** is a sample of a GOOD Tyco/Augit socket.
- Socket **"C"** is a sample of a GOOD FCI socket.
- Socket **"D"** is a sample of a DEFECTIVE Tyco socket.

The sockets above labeled **"A", "B" or "C"** are good and should NOT be replaced.
The socket above labeled **"D"** is considered defective should be replaced.

Any Model having a serial number starting and ending with the serial numbers shown in the chart below should have the socket 68-PIN PLCC SOCKET - P/N 1200-1274 (Circuit Reference "U001") **REPLACED!**

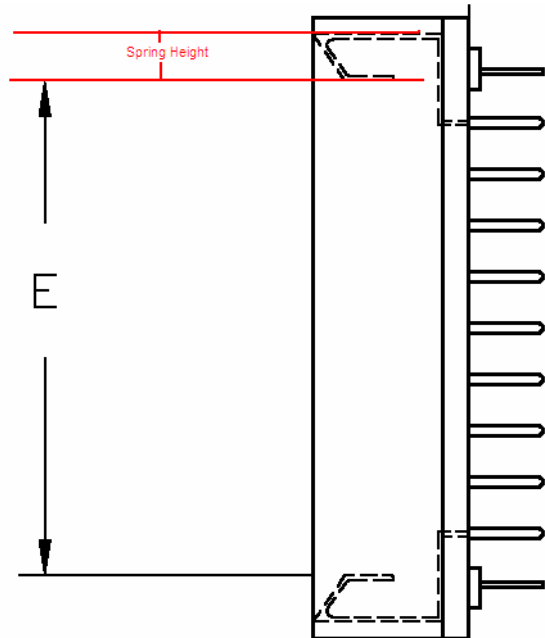
The condition of the recessed beams has been corrected by a design enhancement implemented in production. This design enhancement increased the spring height dimension by 0.04mm and decreased the spring height tolerance by 40%. The spring height dimension is shown in the drawing below.

This design enhancement is intended to position the contact beams closer to the middle of the socket and increase the normal force exerted on the contacts of the chips mated to the socket.
