66102A-08A

S E R V I C E N O T E

66102A DC Power Supply

The instrument will not communicate or will not complete self test.

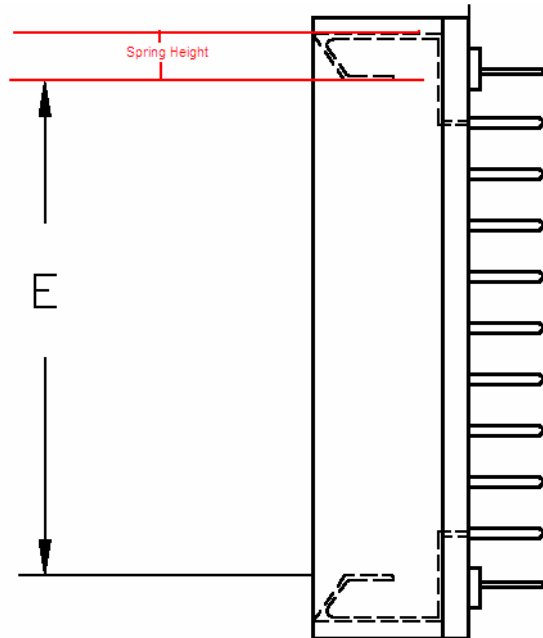
The condition of the recessed beams has been corrected by a design enhancement implemented in production. This design enhancement increased the spring height dimension by 0.04mm and decreased the spring height tolerance by 40%. The spring height dimension is shown in the drawing below.

This design enhancement is intended to position the contact beams closer to the middle of the socket and increase the normal force exerted on the contacts of the chips mated to the socket.

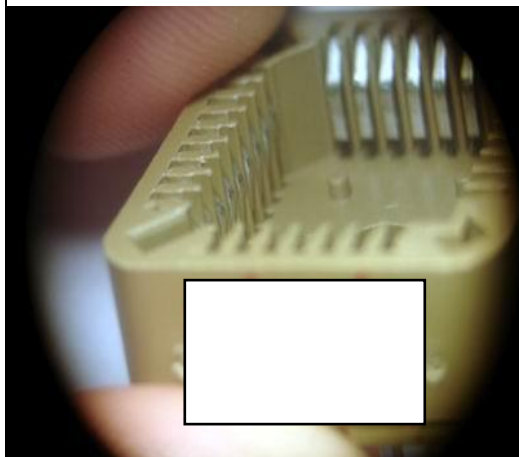
The effectiveness of this design enhancement was tested by comparing the mating and un-mating forces on the older and newer designs. The test results for sockets with the increased spring height (newer design) showed an increase in the mean mating force of 18.9% and an increase in the mean un-mating force of 23.4%. The increase in the un-mating force test results between the old design and the new design indicate that a greater normal force is being exerted on the test chip contacts by the socket contact beams. The two revisions of this contact beam design were visually examined after the mating and un-mating force testing. Photos of the two sockets are shown below. The photo on the left shows the older version socket prior to the enhanced contact beam design. The photo on the right shows a socket with the design enhancement. The contacts with the older design appear to be recessed farther into the housing after un-mating.

Material with this design enhancement will be labeled with a 2007 date code
