# 66103A-08A

# S E R V I C E N O T E

## 66103A DC Power Supply

**The instrument will not communicate or will not complete self test.**

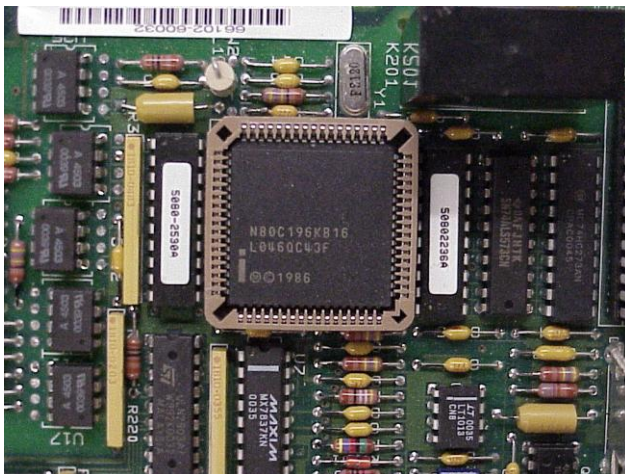
Figure 1 will help to identify the **68-PIN PLCC SOCKET location - P/N 1200-1274** (Circuit Reference “U001”)

Any Model having a serial number starting and ending with the serial numbers shown in the chart below should have the socket 68-PIN PLCC SOCKET - P/N 1200-1274 (Circuit Reference "U001") **REPLACED!**

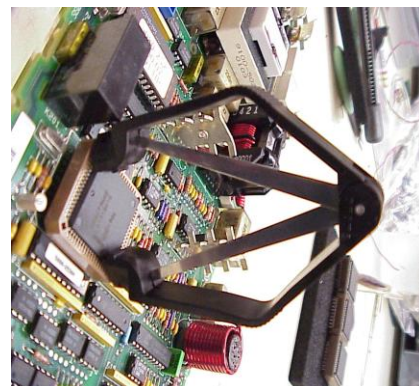
**Figure 2**

This picture shows the required tool used to remove the processor

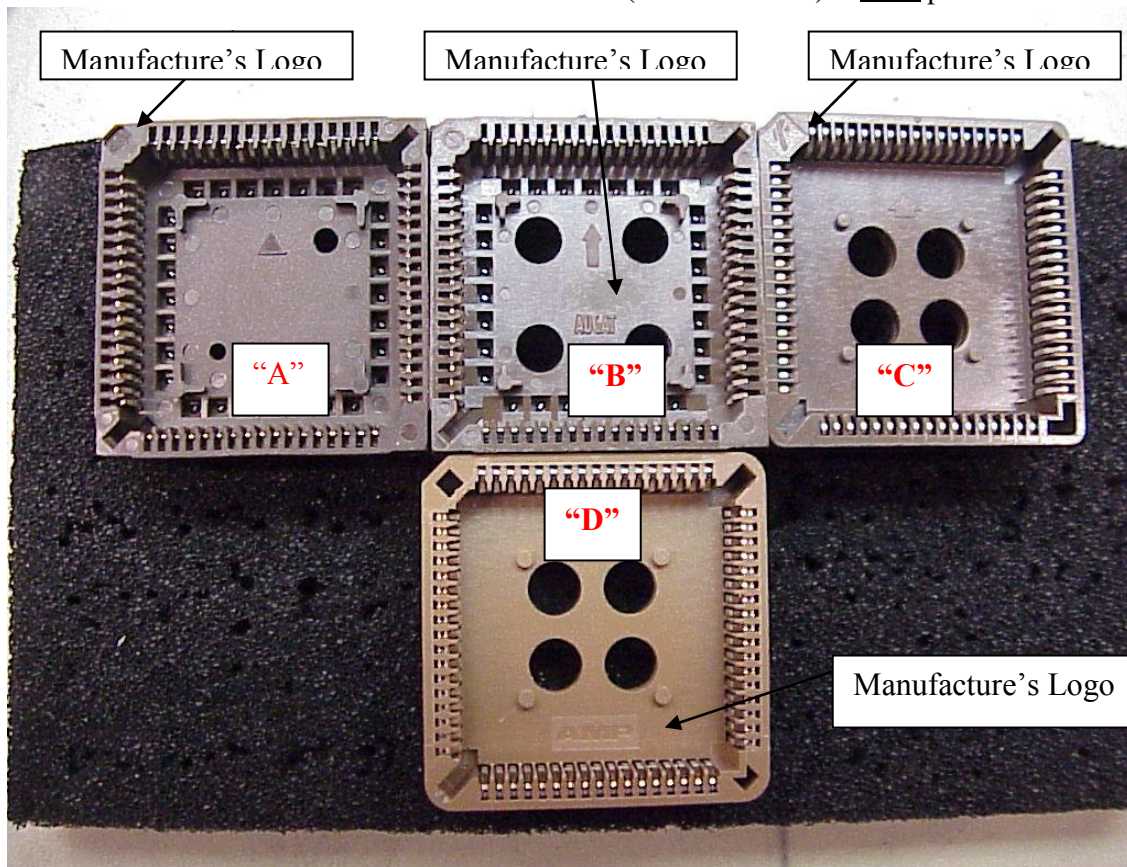
This figure should be used to identify **GOOD** sockets and a potential defective socket. The **16-Bit MCU 16 MHZ 68PLCC CMOS IC (P/N 1821-1479)** is **NOT** pictured.

The following information will help identify each socket type and manufacturer. The manufacturer's logo can be identified as shown. After the **16-Bit MCU 16 MHZ 68PLCC CMOS IC** has been removed there are also mold markings that can be easily viewed these markings should be used to identify a **Good or Defective socket**.

- Socket **"A"** is a sample of a GOOD AMP socket.
- Socket **"B"** is a sample of a GOOD Tyco/Augit socket.
- Socket **"C"** is a sample of a GOOD FCI socket.
- Socket **"D"** is a sample of a DEFECTIVE Tyco socket.

The sockets above labeled **"A", "B" or "C"** are good and should NOT be replaced.  
The socket above labeled **"D"** is considered defective should be replaced.

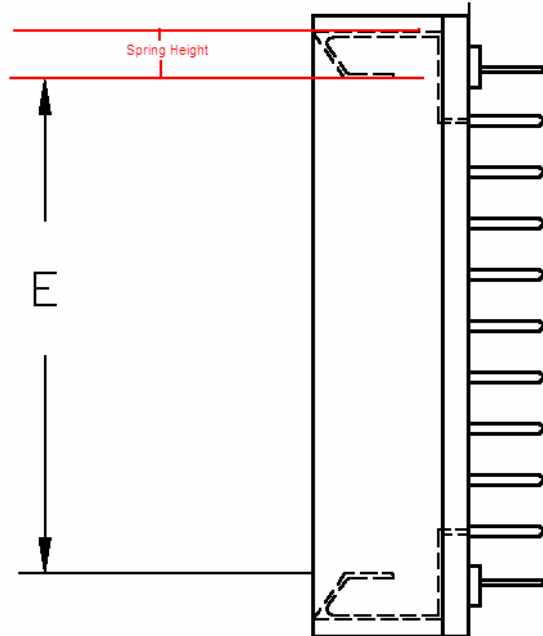
The condition of the recessed beams has been corrected by a design enhancement implemented in production. This design enhancement increased the spring height dimension by 0.04mm and decreased the spring height tolerance by 40%. The spring height dimension is shown in the drawing below.

This design enhancement is intended to position the contact beams closer to the middle of the socket and increase the normal force exerted on the contacts of the chips mated to the socket.

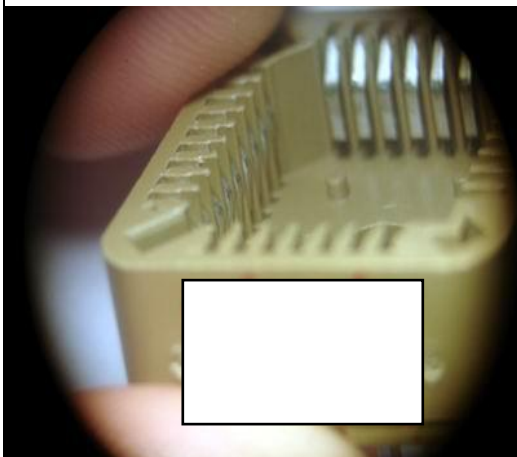
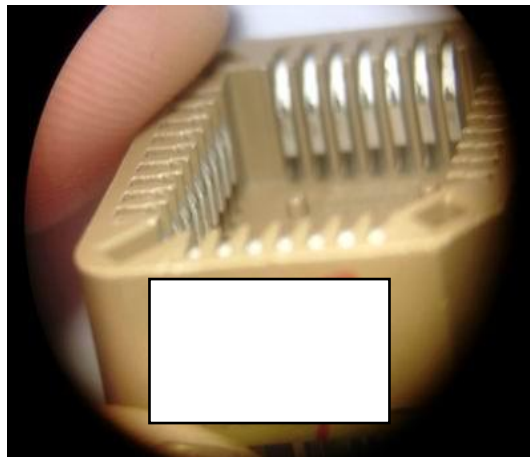
The effectiveness of this design enhancement was tested by comparing the mating and un-mating forces on the older and newer designs. The test results for sockets with the increased spring height (newer design) showed an increase in the mean mating force of 18.9% and an increase in the mean un-mating force of 23.4%. The increase in the un-mating force test results between the old design and the new design indicate that a greater normal force is being exerted on the test chip contacts by the socket contact beams. The two revisions of this contact beam design were visually examined after the mating and un-mating force testing. Photos of the two sockets are shown below. The photo on the left shows the older version socket prior to the enhanced contact beam design. The photo on the right shows a socket with the design enhancement. The contacts with the older design appear to be recessed farther into the housing after un-mating.
