66104A-09A

S E R V I C E N O T E

66104A DC Power Supply

The instrument will not communicate or will not complete self test.

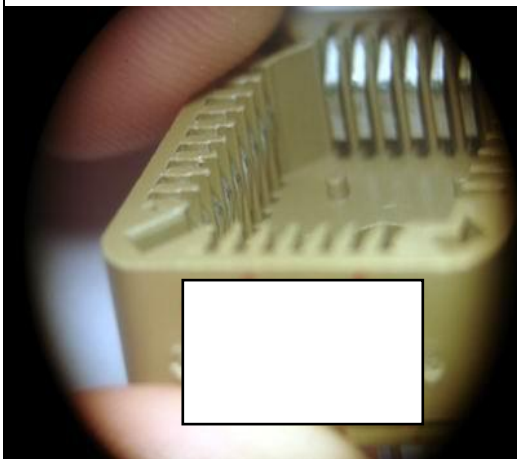
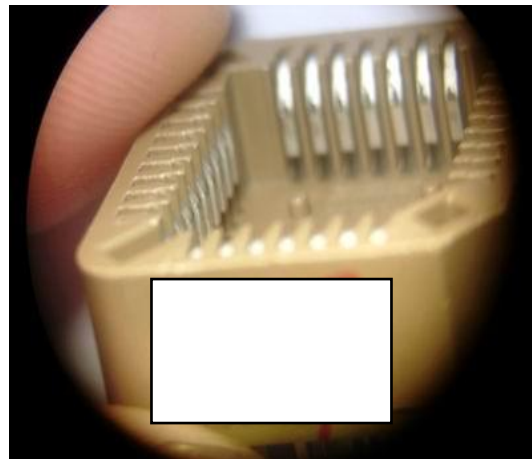
The effectiveness of this design enhancement was tested by comparing the mating and un-mating forces on the older and newer designs. The test results for sockets with the increased spring height (newer design) showed an increase in the mean mating force of 18.9% and an increase in the mean un-mating force of 23.4%. The increase in the un-mating force test results between the old design and the new design indicate that a greater normal force is being exerted on the test chip contacts by the socket contact beams. The two revisions of this contact beam design were visually examined after the mating and un-mating force testing. Photos of the two sockets are shown below. The photo on the left shows the older version socket prior to the enhanced contact beam design. The photo on the right shows a socket with the design enhancement. The contacts with the older design appear to be recessed farther into the housing after un-mating.
