# 66105A-09A

# S E R V I C E N O T E

## 66105A DC Power Supply

**The instrument will not communicate or will not complete self test.**

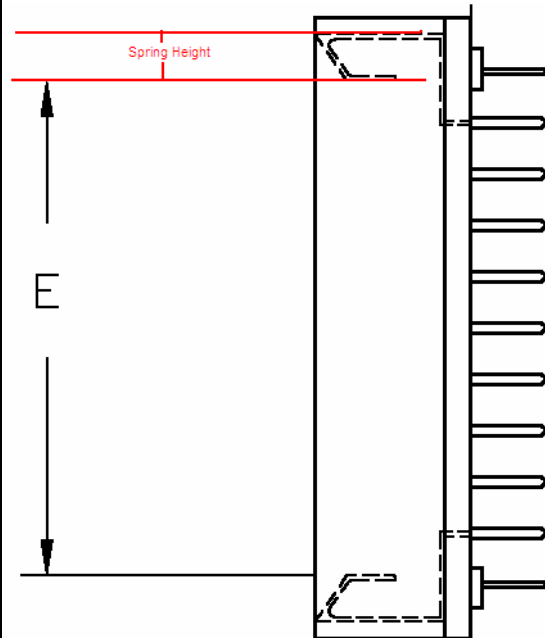
The condition of the recessed beams has been corrected by a design enhancement implemented in production. This design enhancement increased the spring height dimension by 0.04mm and decreased the spring height tolerance by 40%. The spring height dimension is shown in the drawing below.

This design enhancement is intended to position the contact beams closer to the middle of the socket and increase the normal force exerted on the contacts of the chips mated to the socket.

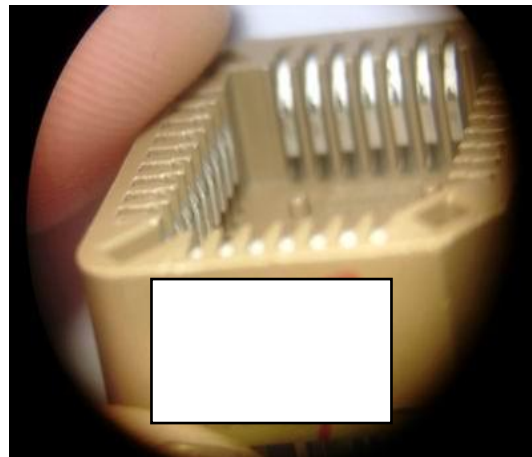
The effectiveness of this design enhancement was tested by comparing the mating and un-mating forces on the older and newer designs. The test results for sockets with the increased spring height (newer design) showed an increase in the mean mating force of 18.9% and an increase in the mean un-mating force of 23.4%. The increase in the un-mating force test results between the old design and the new design indicate that a greater normal force is being exerted on the test chip contacts by the socket contact beams. The two revisions of this contact beam design were visually examined after the mating and un-mating force testing. Photos of the two sockets are shown below. The photo on the left shows the older version socket prior to the enhanced contact beam design. The photo on the right shows a socket with the design enhancement. The contacts with the older design appear to be recessed farther into the housing after un-mating.

Material with this design enhancement will be labeled with a 2007 date code
