6612C-07A

S E R V I C E N O T E

Agilent 6612C DC Power Supply

On faster computers, when programming over GPIB, a random error will occur.

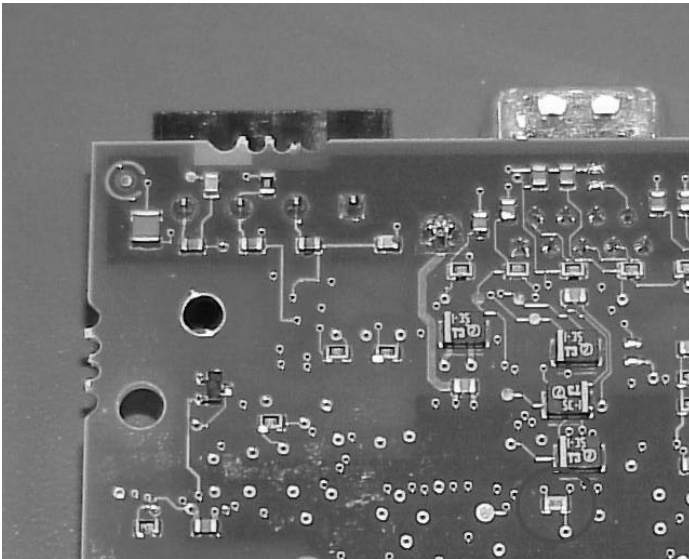
When programming a unit over GPIB, a random error -113 (“Undefined header”) will appear on the unit. This error can be read back via the front panel or over the GPIB bus.

Change resistor R1246 (see picture for location) from 511 Ohms to 100 Ohms (part number 0699-3058). This requires un-soldering and soldering a surface mount component and can be very difficult. This does not require re-calibration.

Replace the entire GPIB assembly (part number 5063-4841) with a newer one that has the 100 Ohm resistor. This will require the unit to be re-calibrated.
