66309B-05

S E R V I C E N O T E

66309B

Reliability Improvement of Instrument

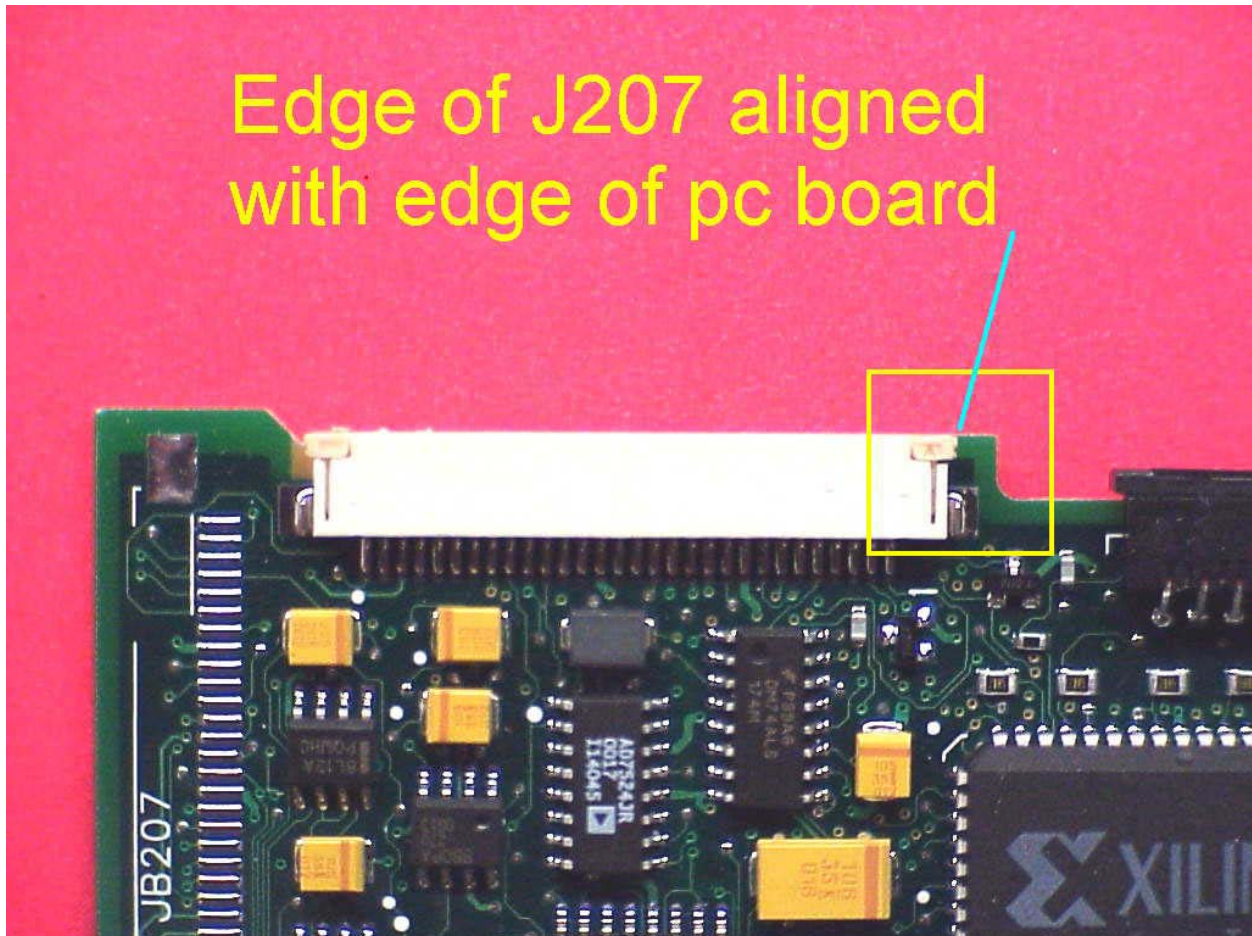
CORRECT J207 PLACEMENT – alignment to within $< 0.3\text{mm}$

Picture shows connector aligned to edge of SMT board to within $< 0.1\text{mm}$
