66309B-09

S E R V I C E N O T E

**66309B – Mobile Communication DC Source, Dual-Output
15V/3A,12V/1.5A. GPIB**

**Power-On Self test Errors, Auto reboot, Blank display. No output Communication errors.
No communication when using the GPIB Interface.**

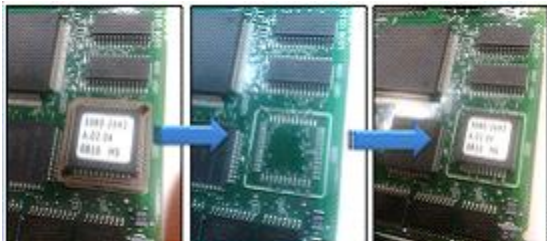
It has been determined when removing the socket and soldering the EEPROM (circuit reference U205) directly on the interface assembly “A2” would be very difficult (See Picture below), even having the correct tools, removal of the socket and replacement of the EEPROM is very difficult and may cause additional quality and reliability issues.

The EEPROM may have bent and or dirty pins. Bent Pins and dirty pins will cause reliability problems. The EEPROM can be over heated and damaged during this procedure and will cause reliability problems. The EEPROM is a static sensitive device and can be damaged due to ESD.

1. This problem can be solved by replacing the GPIB Interface assembly. See above for the tested interface P/N that is required to repair the instrument. The correct tested assembly for the specific model must be used when repairing a defective instrument.
2. This problem can also be solved by removing the socket (circuit reference U205) on the “A2” interface assembly and soldering the **Original** EEPROM directly to the Printed Circuit assembly.
