66311D-07

S E R V I C E N O T E

Agilent 66311D DC Power Supply

On faster computers, when programming over GPIB, a random error will occur.

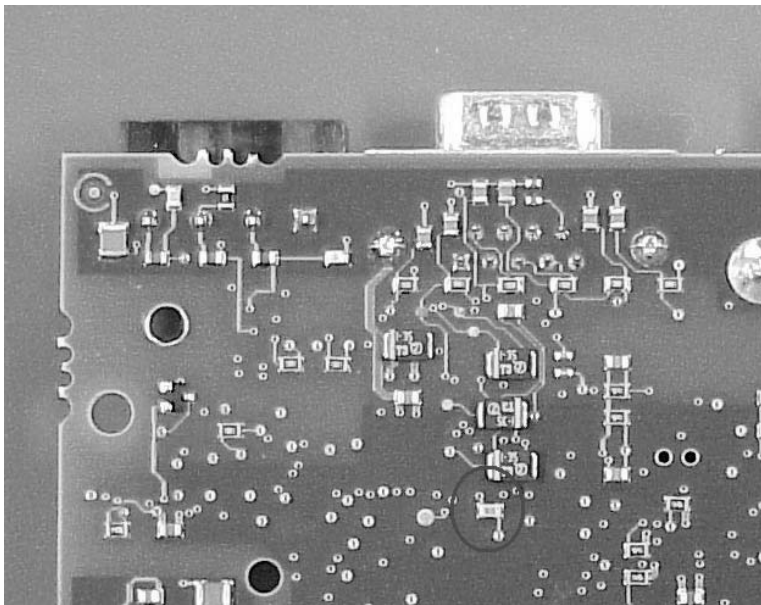
When programming a unit over GPIB, a random error -113 (“Undefined header”) will appear on the unit. This error can be read back via the front panel or over the GPIB bus.

Change resistor R1246 (see picture for location) from 511 Ohms to 100 Ohms (part number 0699-3058). This requires soldering a surface mount component and can be very difficult. This does not require re-calibration.
