66319B-07

S E R V I C E N O T E

Agilent 66319B DC Power Supply

On faster computers, when programming over GPIB, a random error will occur.

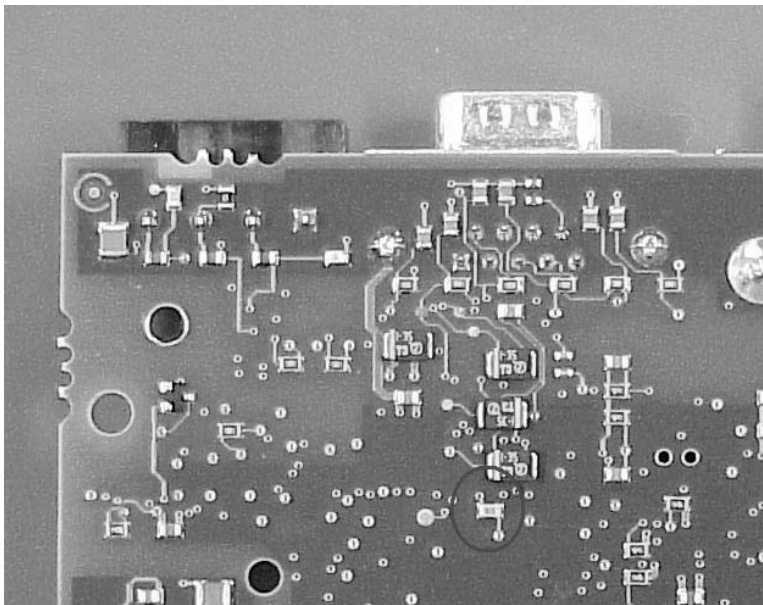
When programming a unit over GPIB, a random error -113 (“Undefined header”) will appear on the unit. This error can be read back via the front panel or over the GPIB bus.

Change resistor R1246 (see picture for location) from 511 Ohms to 100 Ohms (part number 0699-3058). This requires soldering a surface mount component and can be very difficult. This does not require re-calibration.
