66319B-09

S E R V I C E N O T E

**66319B - Mobile Communication DC Source, Dual-Output
15V/3A,12V/1.5A. GPIB**

**Power-On Self test Errors, Auto reboot, Blank display. No output Communication errors.
No communication when using the GPIB Interface.**

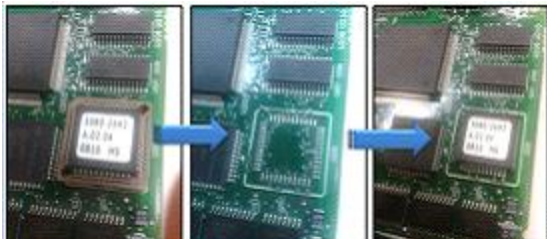
When the EEPROM is installed in the PLCC SOCKET (**Circuit Reference U205**) on the Interface board if there is not a gas tight connection between the EEPROM pins and the socket pins an intermittent connection will occur.

It has been determined when removing the socket and soldering the EEPROM (circuit reference U205) directly on the interface assembly “A2” would be very difficult (See Picture below), even having the correct tools, removal of the socket and replacement of the EEPROM is very difficult and may cause additional quality and reliability issues.

The EEPROM may have bent and or dirty pins. Bent Pins and dirty pins will cause reliability problems. The EEPROM can be over heated and damaged during this procedure and will cause reliability problems. The EEPROM is a static sensitive device and can be damaged due to ESD.

1. The problem can be solved by replacing the GPIB Interface assembly. See above for the tested interface P/N that is required to repair the instrument. The correct tested assembly for the specific model must be used when repairing a defective instrument.
2. This problem can also be solved by removing the socket (circuit reference U205) on the “A2” interface assembly and soldering the **Original** EEPROM directly to the Printed Circuit assembly Initialization and calibration problems.
