66319B-521-01

S E R V I C E N O T E

66319B with Option #521

Reliability Improvement of Instrument

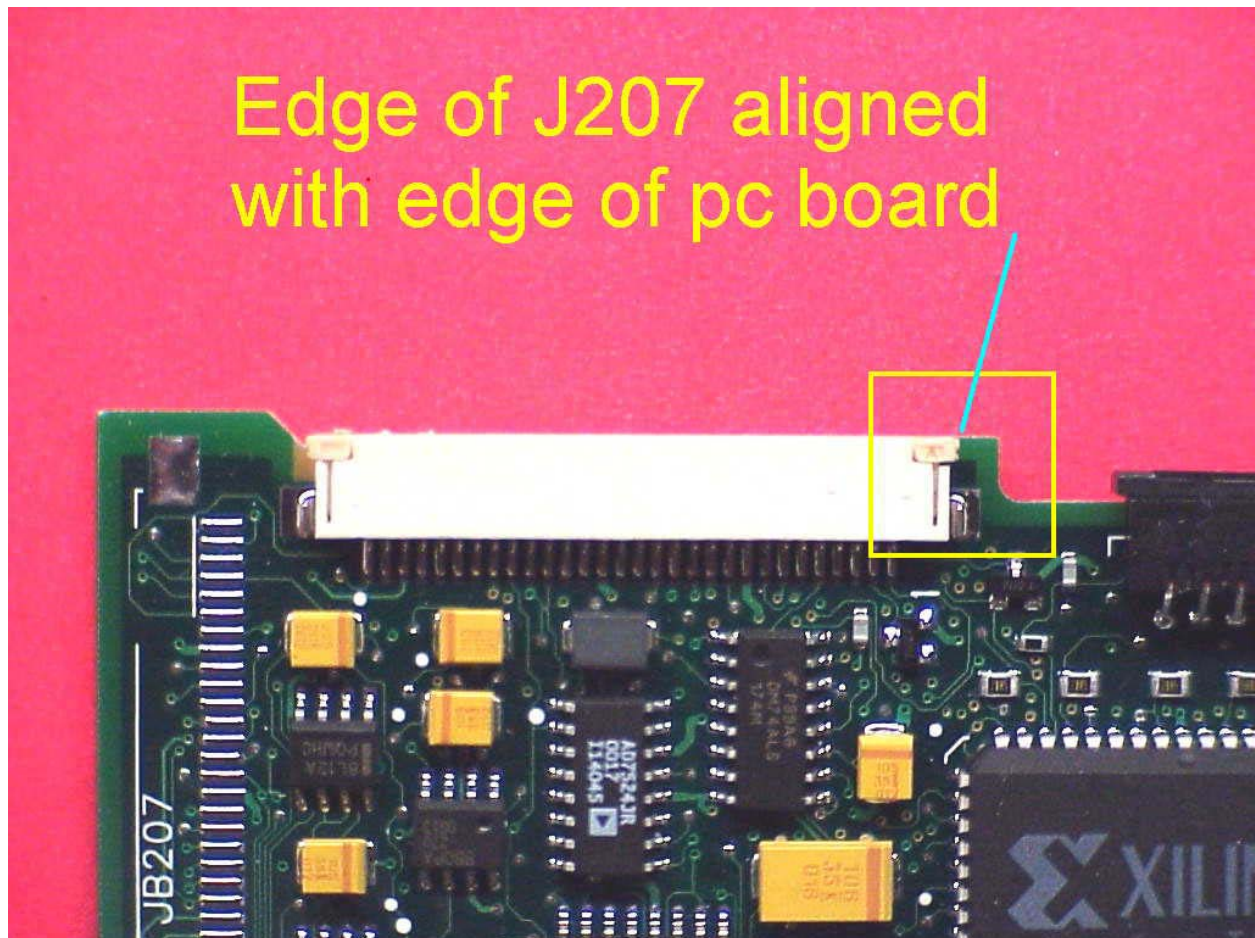
CORRECT J207 PLACEMENT – alignment to within $< 0.3\text{mm}$

Picture shows connector aligned to edge of SMT board to within $< 0.1\text{mm}$
