66319D-09

S E R V I C E N O T E

66319D - Mobile Communication Dual-Output DC Source,
With Battery Emulation, DVM. GPIB.

**Power-On Self test Errors, Auto reboot, Blank display. No output Communication errors.
No communication when using the GPIB Interface.**

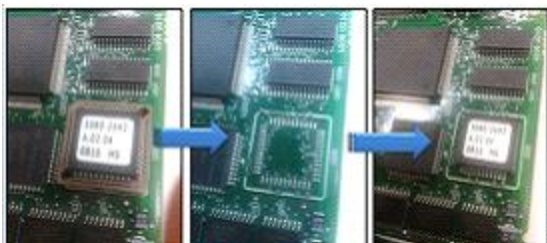
It has been determined when removing the socket and soldering the EEPROM (circuit reference U205) directly on the interface assembly “A2” would be very difficult (See Picture below), even having the correct tools, removal of the socket and replacement of the EEPROM is very difficult and may cause additional quality and reliability issues.

The EEPROM may have bent and or dirty pins. Bent Pins and dirty pins will cause reliability problems. The EEPROM can be over heated and damaged during this procedure and will cause reliability problems. The EEPROM is a static sensitive device and can be damaged due to ESD.

1. The problem can be solved by replacing the GPIB Interface assembly. See above for the tested interface P/N that is required to repair the instrument. The correct tested assembly for the specific model must be used when repairing a defective instrument.
2. This problem can also be solved by removing the socket (circuit reference U205) on the “A2” interface assembly and soldering the **Original** EEPROM directly to the Printed Circuit assembly.
