66321B-07

S E R V I C E N O T E

Agilent 66321B DC Power Supply

On faster computers, when programming over GPIB, a random error will occur.

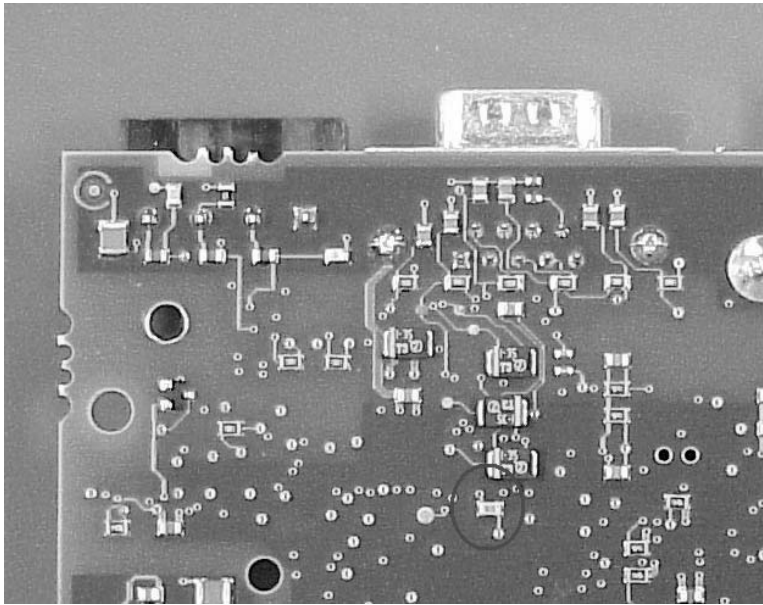
When programming a unit over GPIB, a random error -113 (“Undefined header”) will appear on the unit. This error can be read back via the front panel or over the GPIB bus.

Change resistor R1246 (see picture for location) from 511 Ohms to 100 Ohms (part number 0699-3058). This requires soldering a surface mount component and can be very difficult. This does not require re-calibration.
