6632B-09

**S E R V I C E N O T E**

Agilent 6632B DC Power Module

There is a possible glitch on the output due to an AC Line sag between 23 VAC to 27 VAC.

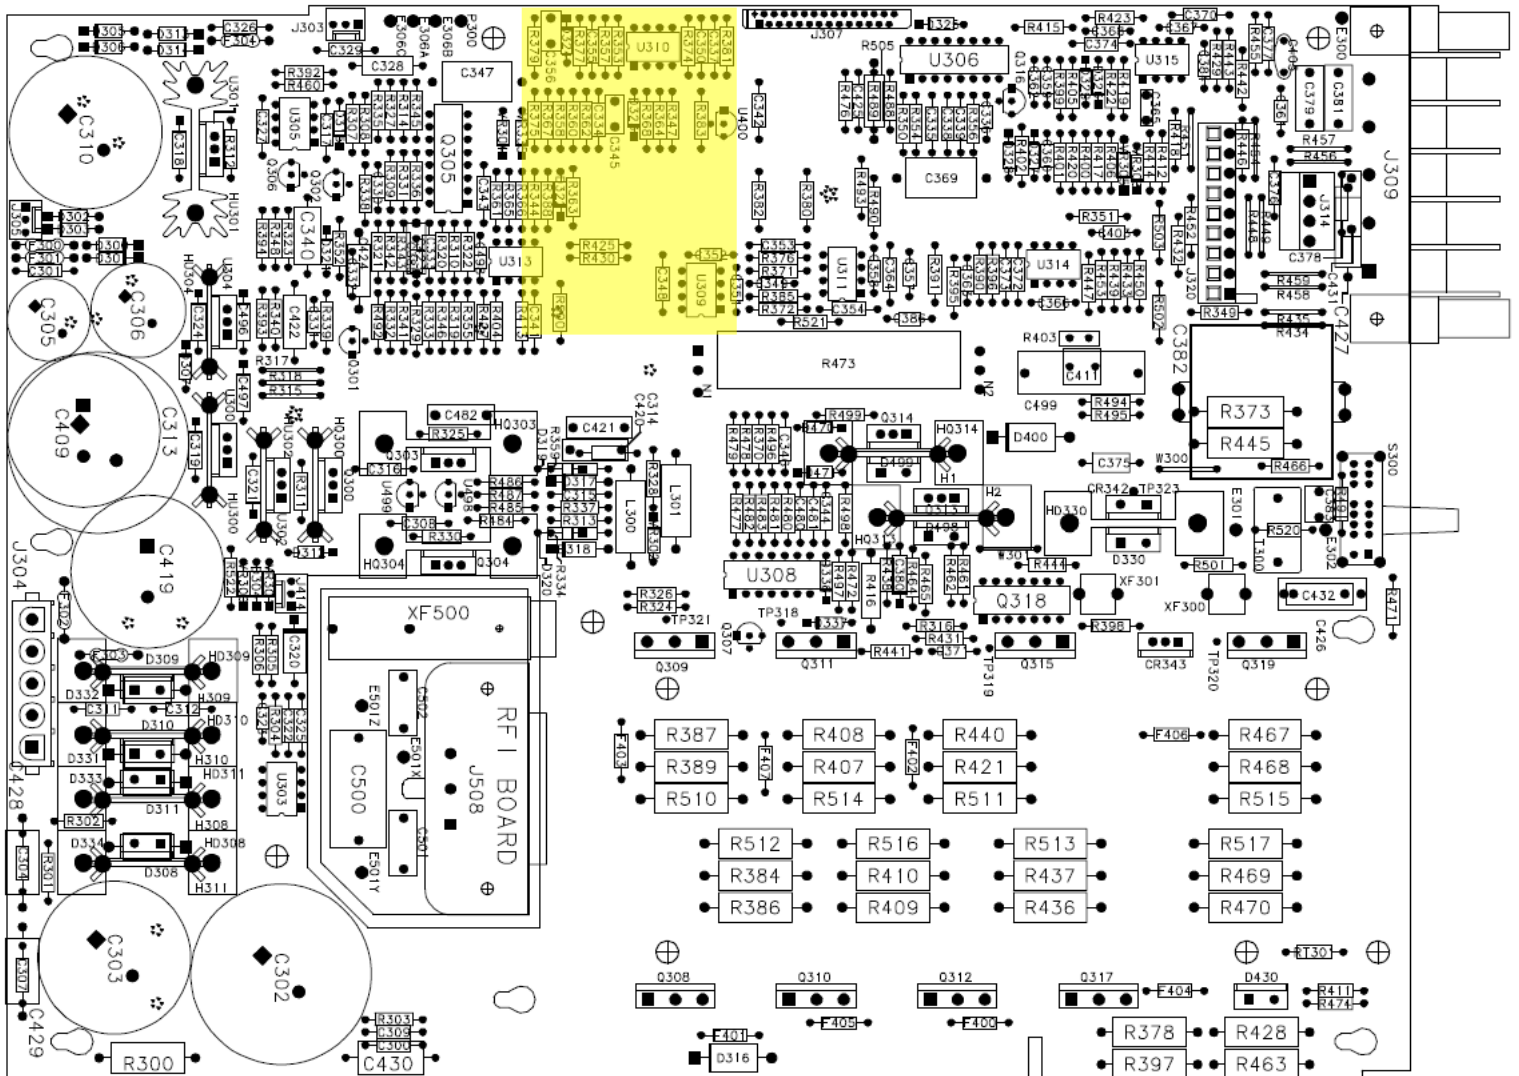
**Figure 1. A1 Board Layout**

The figures below show where to solder the diode (P/N 1901-1344) from R358 to C345 on the A1 main board.

The solution is to implement a diode (P/N 1901-1344) that clamps the op-amp to 0.7 V. This prevents the op-amp from driving the output on, and does not affect it due to a normal operation at -5V DC.
