6671A-10

**S E R V I C E N O T E**

**6671A - DC POWER SUPPLY, 0-8 V, 0-220 A, 1760 W.  
GPIB CONTROLLED**

**The four filter capacitors circuit reference (C416-C419) on the A4 AC input board starts leaking electrolyte**

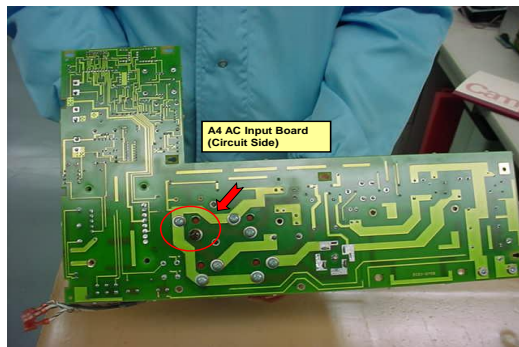
The four filter capacitors circuit reference (C416-C419) on the A4 AC input board starts leaking electrolyte - not through the pressure valve in the bottom as one would expect but through one of the terminal screw bushings.”

The screw P/N 2680-0217 length currently being used was not considered and the length was overlooked. The screw length is 0.375 inches long. We have found that the screw can be 0.055 inches too long and may bottom out causing the tapped hole in the header of the capacitor to become cracked or become broken.

When this happens the electrolyte will slowly leak out over time, and cause the defect described. This situation is even worse due to the capacitor is mounted with the header face down. If the capacitor was mounted header face up a cracked or broken header would not have caused this problem, the electrolyte could not leak out.

1. All affected models and tested assemblies WIP (Work In Process), FGI (Finished Goods Inventory) at SPO (Support Parts Organization) & AMC (Asian Manufacturing Center) has been inspected for capacitors with damaged headers due to the incorrect screw
2. When this repair is being done all of the hardware described above should be replaced (It is NOT recommended that any of the hardware be reused)
3. The following figures can be used when doing the repair.
4. Inspect the assembly as described below.
5. The last figure will aid in the reassembly of the hardware and the capacitors.
