**6672A-07A**

**S E R V I C E N O T E**

**6672A DC POWER SUPPLY GPIB CONTROLLED**

**The Current Shunt (Circuit Reference “R907”) may have intermittent sense wires, which may cause Instability of Current regulation, Current read back and current programming.**

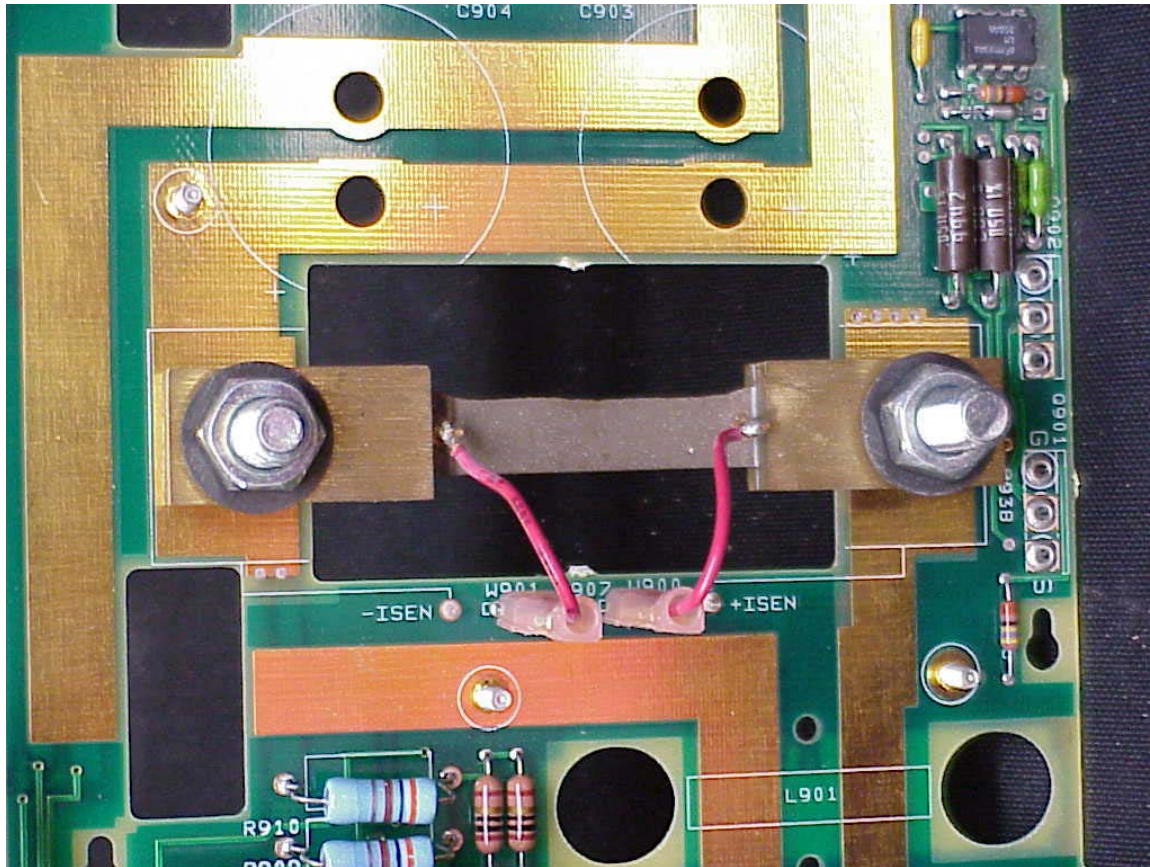
When the push-on connectors become intermittent the output current will become unstable. Loose push-on connectors can cause the output current to change dramatically. The current can change from any set current, and may go to the maximum rated output current of the instrument.

This picture shows how the Shunt R907 is connected using the term-crimp connectors.

The Shunt R907 is connected to "W900" & "W901"

Cut the terminal-crimp connectors off of both wires and discard the connectors. Make this cut as close to the terminal-crimp connector as possible. The required strip length should be 5mm. This strip length will be used to prevent the wire length being too long and shorting to the instrument chassis. If replacement of this wire is required any color (22 AWG, 300V 105C) wire type can be used.

This modification can be done from the top of the board. Carefully strip and solder the wires, and avoid burning the wire insulation and the printed circuit board.
