MODIFICATION RECOMMENDED

6672A-11

S E R V I C E N O T E

**6672A DC POWER SUPPLY, 0-20V, 0-100 A, 2000 W.
MANUALLY CONTROLLED.**

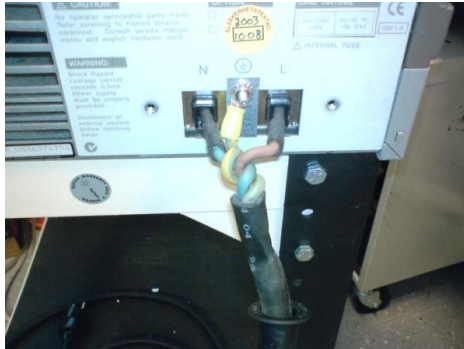
Figure 1 is an example of what happens when the strain relief becomes loose, the line cord becomes twisted. When a heavy line cord is used the strain relief becomes loose very easily, and the line cord cable can rotate freely.

The entire **AC INPUT SAFETY COVER** P/N 5040-1676 should be replaced.

The line cord should be securely fastened at a point 6 to 12 inches away from **INPUT SAFETY COVER** as shown in [Figure 7](#). When this type of strain relief is used the electrical code requires the cord/cable being held by the strain relief be secured. Doing this eliminates the cable or cord from being twisted as shown in figure 1.

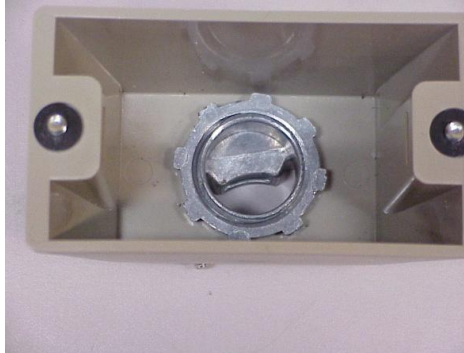
Figure 2 shows the inside of the AC Safety Cover housing the incorrect hardware is shown. It will be very difficult to tighten the strain relief. AMC (Asian Manufacturing Center) uses a special tool to tighten the locking nut. When the incorrect nut is used or a locking Nut is put on incorrectly the strain relief will become loose as described above.

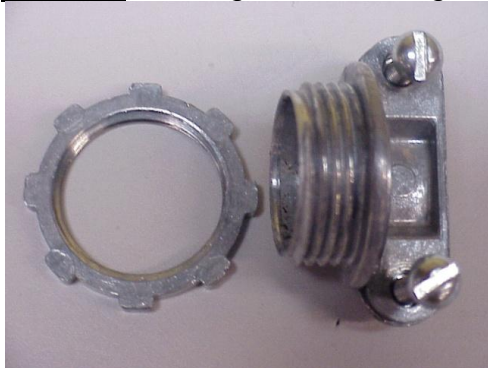
Figures 3 & 5 is representative of a not without locking ribs.

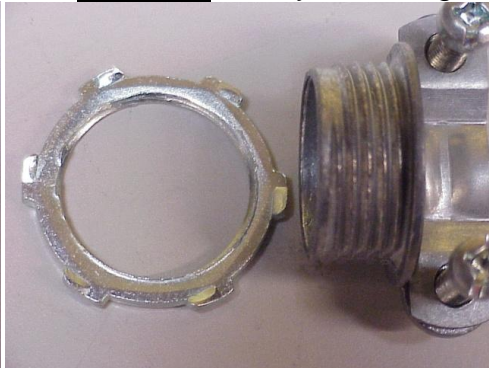
Figures 4 & 6 is representative of a nut with locking ribs.

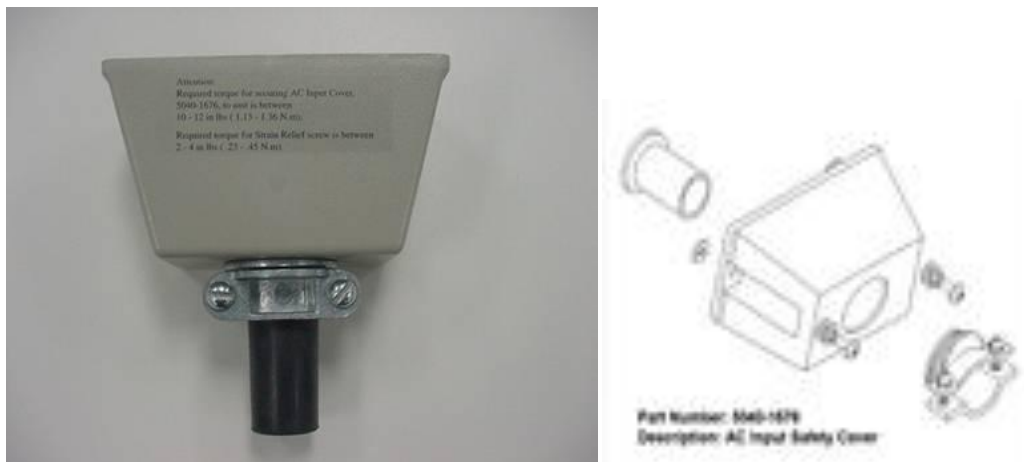
The individual parts shown in [Figure 8](#) are not available from Agilent parts “SPO” (Support Parts Organization). It is not cost affective to repair the **AC INPUT SAFETY COVER**, a special tool is required to tighten the nut shown in Figure 2.

The information below is what is printed on the label shown in [Figure 8](#)

ONLY replace the AC Safety Cover P/N 5040-1676 if the label shown in Figure 8 does not appear on the Safety cover or if the Cover is defective due to described failure, the Safety cover should be replaced at **NO** charge to the customer.

Required torque for securing AC Input Cover,
5040-1676, to unit is between
10 – 12 in lbs (1.13 – 1.26 N.m).

Required torque for Strain Relief screw is between
tightened using 2inlb torque.
