6672A-13

Modification Recommended Service Note

6672A DC power supply, 0-20 V, 0-100 A, 2000 W. GPIB

Serial Numbers: "MY53000140 to MY53000698 and SG53000101 to SG53000108"

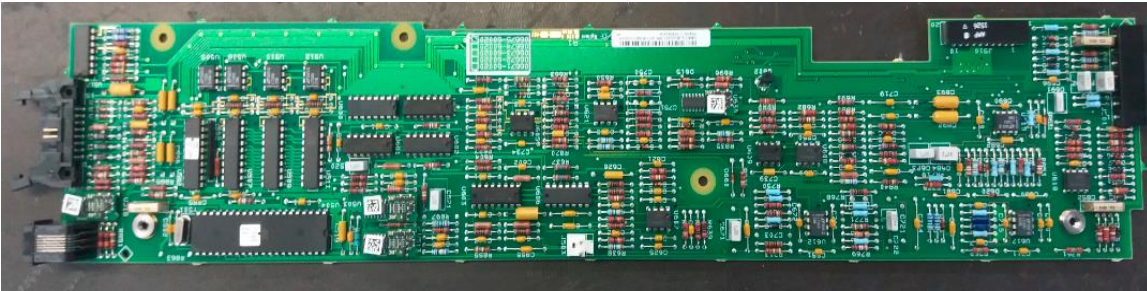
6672A exhibited out of specification values for 8.5V to 9.5V at front panel read back readings. Other ranges and remote programming's behaved normally.

6. Replace with a new PCA board (06672-61020).
