6673A-09

S E R V I C E N O T E

6673A - DC POWER SUPPLY, 0-35 V, 0-60 A, 2100 W. GPIB
CONTROLLED

Serial Numbers: MY41000101/ MY41002666 SG41000101/ SG41000441

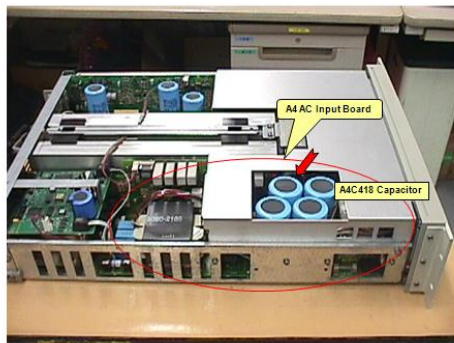
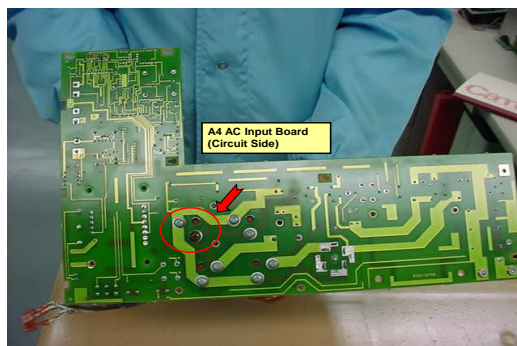
The four filter capacitors circuit reference (C416-C419) on the A4 AC input board starts leaking electrolyte - not through the pressure valve in the bottom as one would expect but through one of the terminal screw bushings.”

The screw P/N 2680-0217 length currently being used was not considered and the length was overlooked. The screw length is 0.375 inches long. We have found that the screw can be 0.055 inches too long and may bottom out causing the tapped hole in the header of the capacitor to become cracked or become broken.

When this happens the electrolyte will slowly leak out over time, and cause the defect described. This situation is even worse due to the capacitor is mounted with the header face down. If the capacitor was mounted header face up a cracked or broken header would not have caused this problem, the electrolyte could not leak out.

1. All affected models and tested assemblies WIP (Work In Process), FGI (Finished Goods Inventory) at SPO (Support Parts Organization) & AMC (Asian Manufacturing Center) has been inspected for capacitors with damaged headers due to the incorrect screw
2. When this repair is being done all of the hardware described above should be replaced (It is NOT recommended that any of the hardware be reused)
3. The following figures can be used when doing the repair.
4. Inspect the assembly as described below.
5. The last figure will aid in the reassembly of the hardware and the capacitors.
