6674A-12

S E R V I C E N O T E

6674A DC POWER SUPPLY, 0-60 V, 0-35 A, 2100 W. GPIB CONTROLLED.

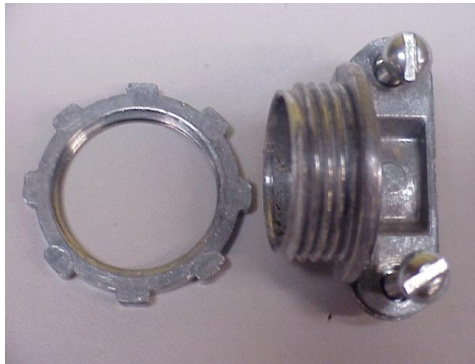
Figure 3 Regal Non locking Nut

Figures 3 & 5 is representative of a not without locking ribs.

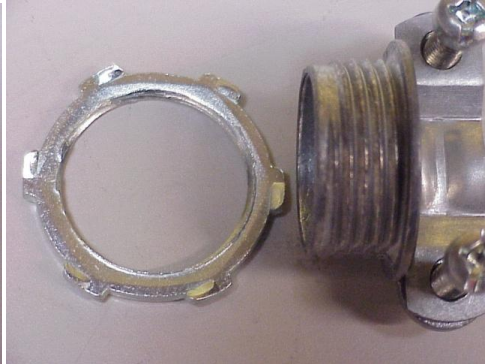
Figure 4 Heyco locking Nut

Figures 4 & 6 is representative of a nut with locking ribs.

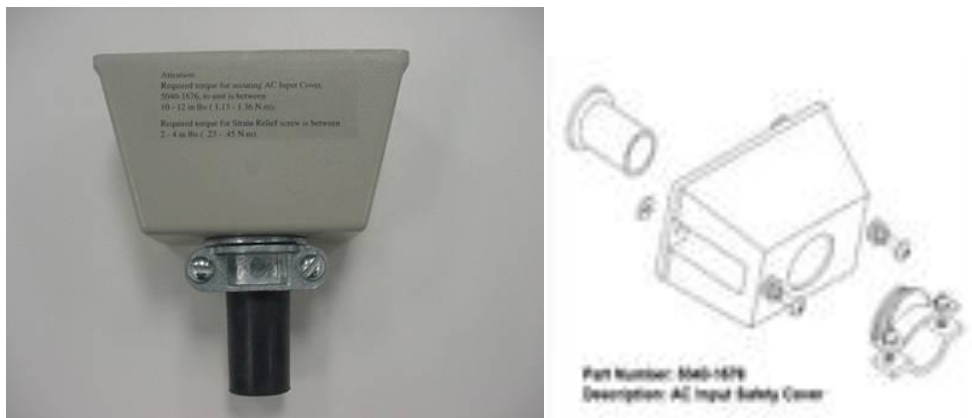
Figure 8

The individual parts shown in [Figure 8](#) are not available from Agilent parts “SPO” (Support Parts Organization). It is not cost affective to repair the AC **INPUT SAFETY COVER**, a special tool is required to tighten the nut shown in Figure 2.

ONLY replace the AC Safety Cover P/N 5040-1676 if the label shown in [Figure 8](#) does not appear on the Safety cover or if the Cover is defective due to described failure, the Safety cover should be replaced at **NO** charge to the customer.

Required torque for securing AC Input Cover,
5040-1676, to unit is between
10 – 12 in lbs (1.13 – 1.26 N.m).

Required torque for Strain Relief screw is between
tightened using 2inlb torque.
