# Modification Recommended Service Note

## 6674A DC power supply, 0-60 V, 0-35 A, 2100 W. GPIB

Serial Numbers: "MY53000140 to MY53000698 and SG53000101 to SG53000108"

The Problem – 6674A exhibited out of specification values for 24V to 28V and 44V to 46V at front panel read back readings.

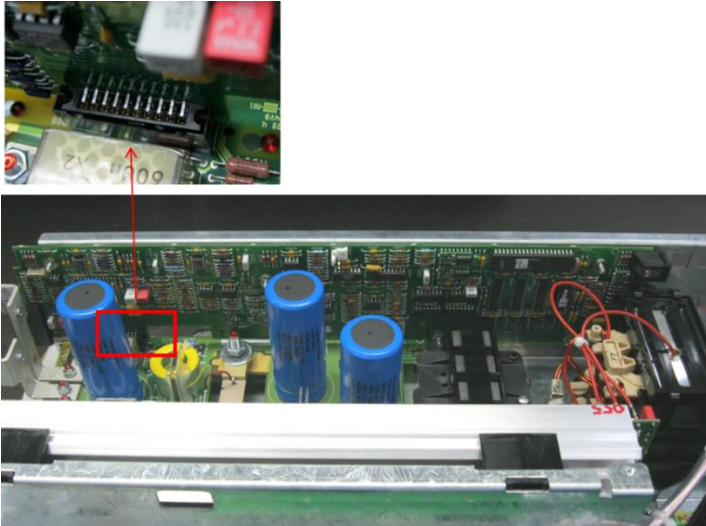
6674A exhibited out of specification values for 24V to 28V and 44V to 46V at front panel read back readings. Other ranges and remote programming's behaved normally.

5. Slide out the affected board from the output board connector.
