**6675A-09A**

**S E R V I C E N O T E**

**6675A DC POWER SUPPLY GPIB CONTROLLED**

**The Current Shunt (Circuit Reference “R907”) may have intermittent sense wires, which may cause Instability of Current regulation, Current read back and current programming.**

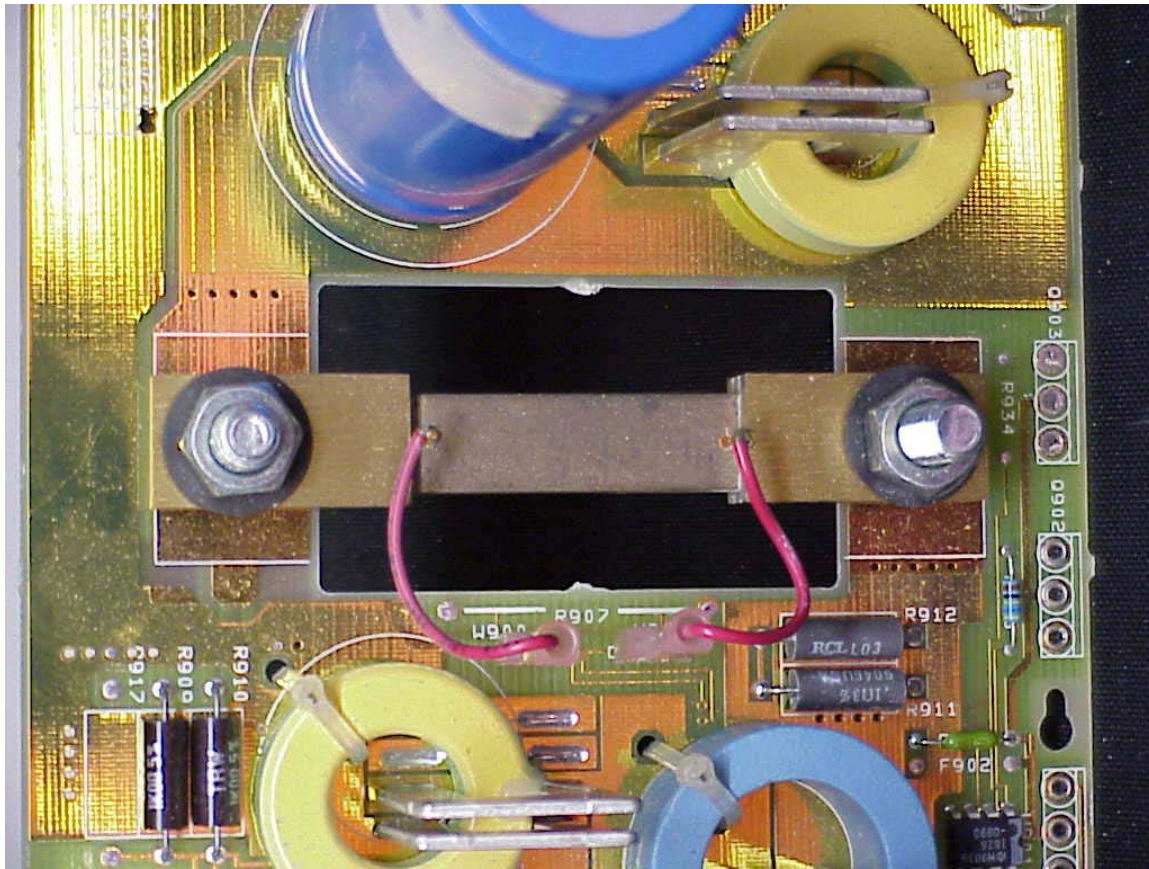
When the push-on connectors become intermittent the output current will become unstable. Loose push-on connectors can cause the output current to change dramatically. The current can change from any set current, and may go to the maximum rated output current of the instrument.

This picture shows how the Shunt R907 is connected using the term-crimp connectors.

The Shunt R907 is connected to "W900" & "W901"

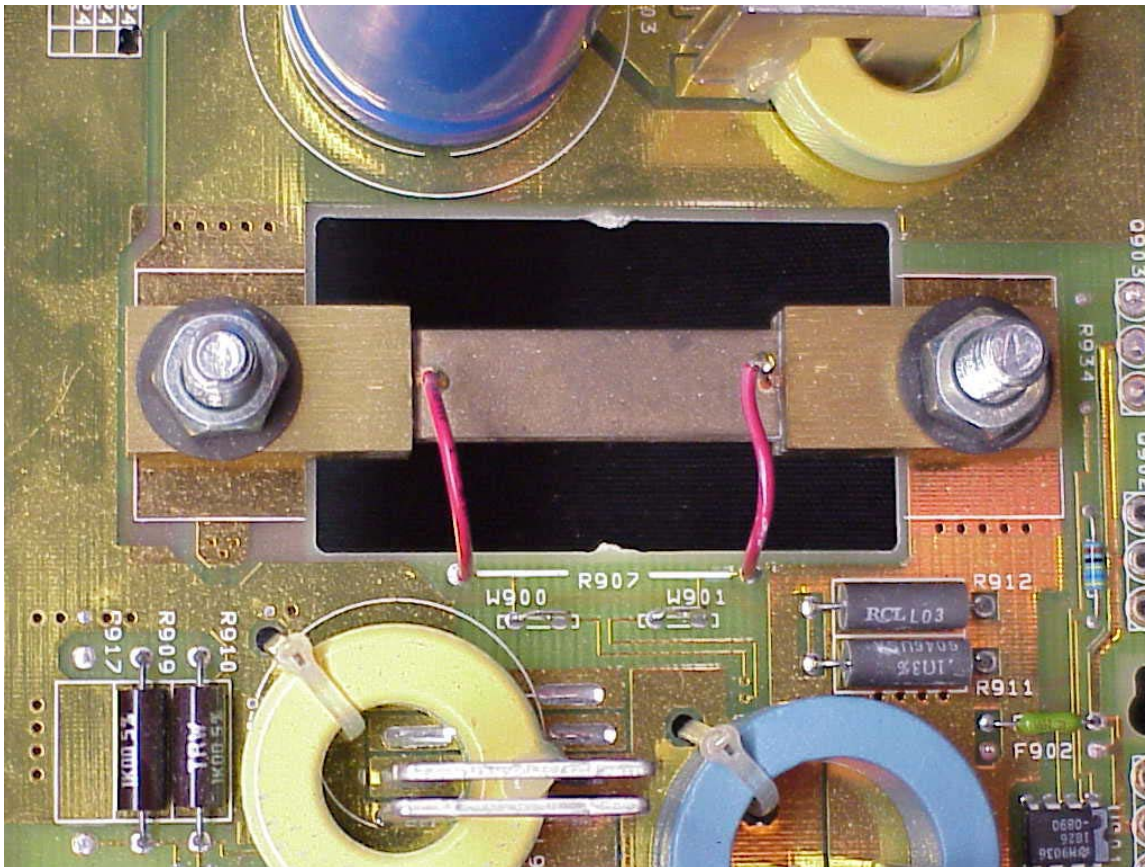
The wires should be connected as shown below. There are two holes marked R907 that should be used. Do not cross the wires when making this modification. See picture below for details. This picture shows the required modification.

Cut the terminal-crimp connectors off of both wires and discard the connectors. Make this cut as close to the terminal-crimp connector as possible. The required strip length should be 5mm. This strip length will be used to prevent the wire length being too long and shorting to the instrument chassis. If replacement of this wire is required any color (22 AWG, 300V 105C) wire type can be used.

This modification can be done from the top of the board. Carefully strip and solder the wires, and avoid burning the wire insulation and the printed circuit board.
